# Access Compliance Report

## Public Rights-of-Way

### (Curb Ramps)

Intersection ID: N/A	Main Street: LAMPMEADE_LN	Cross Street: PORTRUSH_LN	Location: NE
ADA ID: B0B6ABAB0796	Ramp Type: Perp	Initial Pass/Fail: Fail	Overall Compliance: No
Codes/Mitigation Info/Possible Solution		Field Measurements/Component Compliance	
Severity Score: 21.25

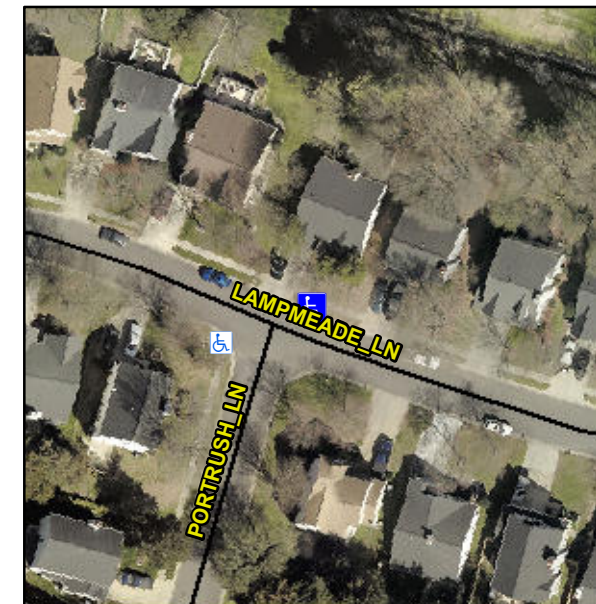
**Not Found, R304.5.1, R304.2.2**

Compliance	Description	Data	Compliance	Description	Data
N/A	Ramp Length (in)	47.5	No	Ramp Slope (%)	8.9
No	Ramp Width (in)	37.0	Yes	Ramp XSlope (%)	0.9
N/A	Flare Type LT	N/A	N/A	Flare Type RT	N/A
N/A	Flare Slope LT (%)	N/A	N/A	Flare Slope RT (%)	N/A
N/A	Flare Traversable LT?	N/A	N/A	Flare Traversable RT?	N/A
N/A	Landing Length (in)	N/A	N/A	DWS Provided?	N/A
N/A	Landing Width (in)	N/A	N/A	DWS Contrast?	N/A
N/A	Landing Slope (%)	N/A	N/A	DWS Length (in)	N/A
N/A	Landing X Slope (%)	N/A	N/A	DWS Full Width?	N/A
N/A	Landing Curb? (Y/N)	N/A	N/A	DWS Offset (in)	N/A
N/A	Shared Landing?	N/A			
N/A	Gutter Ponding?	N/A	N/A	Gutter Slope (%)	N/A
N/A	Gutter Lip Ht (in)	N/A	N/A	Gutter X Slope (%)	N/A
N/A	Painted X Walk1?	No	N/A	Painted X Walk2?	N/A
	X Walk 1 Direction	To SW		X Walk 2 Direction	N/A
N/A	X Walk 1 Width (in)	N/A	N/A	X Walk 2 Width (in)	N/A
	X Walk 1 Slope (%)	3.9		X Walk 2 Slope (%)	N/A
	X Walk 1 X Slope (%)	1.4		X Walk 2 X Slope (%)	N/A

N/A	Ramp inside XWalk1?	N/A	N/A	Ramp inside XWalk2?	N/A
	Road Slope (%)	N/A	N/A	Clear Space?	N/A
	Road X Slope (%)	N/A	N/A	Clear Space to XWalk (in)	N/A
N/A	Any Obstructions?	N/A	N/A	Storm Grate/Utility Hazard?	N/A
	Obstruction Type			Storm Grate/Utility Type	
		N/A			N/A
			Yes	Surface Condition? (G/P)	Good

**Remove & Replace Entire Ramp.**

Total Cost: \$ 1850.00
