Access Compliance Report Public Rights-of-Way (Curb Ramps)

Intersection ID: 43538 Main Street: SUNDANCE_MEADOW_CT Cross Street: PLANTERS_WATCH_DR Location: NW

ADA ID: B0B8B5F7B2AB Ramp Type: PerpDiag Initial Pass/Fail: Fail Overall Compliance: No Severity Score: 13.75

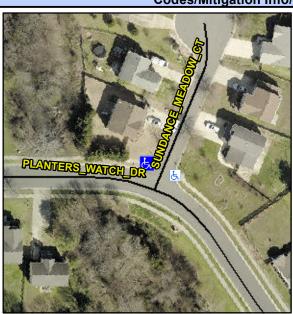
R304.2.2, R304.5.3

Compliance Description Data Compliance Description Data No N/A Ramp Length (in) 42.0 Ramp Slope (%) 9.8 No Ramp XSlope (%) Yes Ramp Width (in) 48.0 2.8 N/A N/A Flare Type LT N/A Flare Type RT N/A N/A N/A N/A Flare Slope RT (%) N/A Flare Slope LT (%) N/A Flare Traversable LT? N/A N/A Flare Traversable RT? N/A N/A N/A N/A **DWS Provided?** N/A Landing Length (in) N/A Landing Width (in) N/A N/A **DWS Contrast?** N/A N/A N/A N/A Landing Slope (%) DWS Length (in) N/A N/A Landing X Slope (%) N/A N/A DWS Full Width? N/A N/A Landing Curb? (Y/N) N/A N/A DWS Offset (in) N/A N/A N/A Shared Landing? N/A Gutter Ponding? N/A N/A Gutter Slope (%) N/A N/A Gutter Lip Ht (in) N/A N/A Gutter X Slope (%) N/A N/A Painted X Walk1? No N/A Painted X Walk2? No X Walk 1 Direction To SW X Walk 2 Direction To SE N/A N/A X Walk 1 Width (in) X Walk 2 Width (in) N/A X Walk 1 Slope (%) 0.6 X Walk 2 Slope (%) 4.9 X Walk 1 X Slope (%) 3.6 X Walk 2 X Slope (%) 0.4 N/A N/A N/A Ramp inside XWalk2? Ramp inside XWalk1? N/A Road Slope (%) 3.4 N/A Clear Space? N/A N/A Road X Slope (%) 2.2 Clear Space to XWalk (in) N/A N/A N/A N/A Any Obstructions? Storm Grate/Utility Hazard? N/A **Obstruction Type** Storm Grate/Utility Type N/A N/A

Remove & Replace Curb Ramp With Two New Directional Ramps or Equivalent.
