Access Compliance Report Public Rights-of-Way (Curb Ramps)

Intersection ID: 21814 Main Str	Main Street: D_DUCKS_LN		Cross Street: WESTINGHOUSE_BV				Location:	NE
ADA ID: B0DC25092707 Ramp Ty	amp Type: PerpDiag		Initial Pass/Fail: Fail Overall Compliance:			nce: N	o Severity Score:	22.5
Codes/Mitigation Info/Possible Solution		Field Measurements/Component Compliance						
ES WESTINGLIOUSELED	Possible Solutions:		Compliance Description		Data	Data Compliance Description		Data
	Remove & Replace Curb Ramp W	Vith	N/A	Ramp Length (in)	47.0	No	Ramp Slope (%)	8.6
	Two New Directional Ramps or		No	Ramp Width (in)	45.5	No	Ramp XSlope (%)	2.4
	Equivalent.		N/A	Flare Type LT	N/A	N/A	Flare Type RT	N/A
			N/A	Flare Slope LT (%)	N/A	N/A	Flare Slope RT (%)	N/A
			N/A	Flare Traversable LT?	N/A	N/A	Flare Traversable RT?	N/A
			N/A	Landing Length (in)	N/A	N/A	DWS Provided?	N/A
	Surveyor Notes:		N/A	Landing Width (in)	N/A	N/A	DWS Contrast?	N/A
	N/A		N/A	Landing Slope (%)	N/A	N/A	DWS Length (in)	N/A

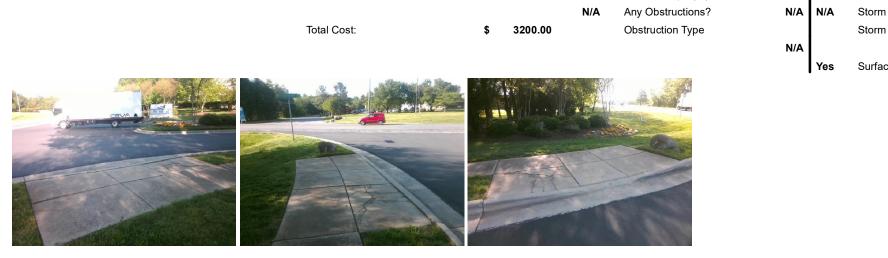
N/A	Landing X Slope (%)	N/A	N/A	DWS Full Width?	N/A
			N/A	Landing Curb? (Y/N)	N/A	N/A	DWS Offset (in)	N/A
			N/A	Shared Landing?	N/A			
	PROW/ADA:		N/A	Gutter Ponding?	N/A	N/A	Gutter Slope (%)	N/A
	Not Found, R304.5.1, R304.2.2, R304.5.3		N/A	Gutter Lip Ht (in)	N/A	N/A	Gutter X Slope (%)	N/A
			N/A	Painted X Walk1?	No	N/A	Painted X Walk2?	No
				X Walk 1 Direction	To SW		X Walk 2 Direction	To SE
			N/A	X Walk 1 Width (in)	N/A	N/A	X Walk 2 Width (in)	N/A
Street 1 Name D DUCKS LN				X Walk 1 Slope (%)	5.5		X Walk 2 Slope (%)	0.3
Stop Condition-Street 2 StopSign				X Walk 1 X Slope (%)	1.0		X Walk 2 X Slope (%)	4.3
Street 2 Name WESTINGHOUSE BV			N/A	Ramp inside XWalk1?	N/A	N/A	Ramp inside XWalk2?	N/A
Stop Condition-Street 1 None				Road Slope (%)	0.7	N/A	Clear Space?	N/A
				Road X Slope (%)	5.2	N/A	Clear Space to XWalk (in)	N/A
			N/A	Any Obstructions?	N/A	N/A	Storm Grate/Utility Hazard?	N/A
	Total Cost: \$ 32	200.00		Obstruction Type			Storm Grate/Utility Type
