# Access Compliance Report

## Public Rights-of-Way

### (Curb Ramps)

| Intersection ID: 14094 | Main Street: BERKELEY_AV | Cross Street: MYRTLE_AV | Location: S |

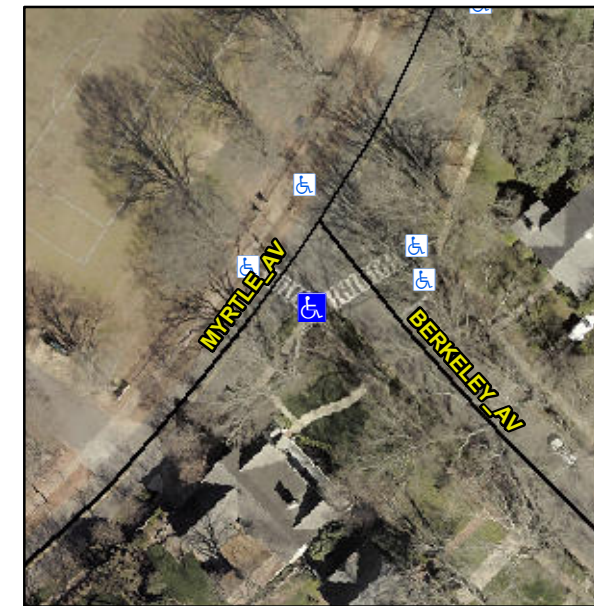
| ADA ID: B0DE7B912844 | Ramp Type: PerpDiag | Initial Pass/Fail: Fail | Overall Compliance: No |

**R304.2.2, R304.5.3**

| Compliance | Description | Data | Compliance | Description | Data |
|---|---|---|---|---|---|
| N/A | Ramp Length (in) | 74.0 | No | Ramp Slope (%) | 9.1 |
| Yes | Ramp Width (in) | 72.0 | No | Ramp XSlope (%) | 5.6 |

**Remove & Replace Curb Ramp With Two New Directional Ramps or Equivalent.**

Total Cost: \$ 3200.00
