# Access Compliance Report

## Public Rights-of-Way

### (Curb Ramps)

Intersection ID: 44417	Main Street: MARVIN_RD	Cross Street: ARDREY_KELL_RD	Location: SW
ADA ID: B0E95445DF88	Ramp Type: Directional1	Initial Pass/Fail: Fail	Overall Compliance: No
		Severity Score: 12.5

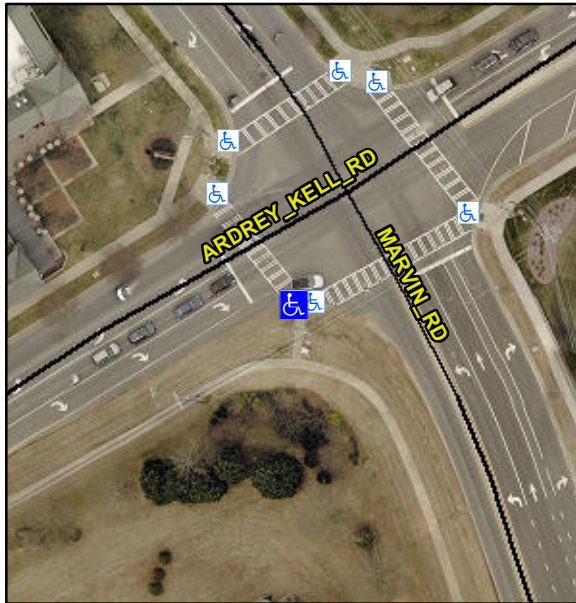
**R304.5.3**

Compliance	Description	Data	Compliance	Description	Data
N/A	Ramp Length (in)	110.0	N/A	Grade Break?	N/A
Yes	Ramp Width (in)	48.0	N/A	Grade Break Slope (%)	0.0
Yes	Ramp Slope (%)	3.6	N/A	Grade Break XSlope (%)	0.0
No	Ramp XSlope (%)	5.3			
N/A	Flare Type LT	N/A	N/A	Flare Type RT	N/A
N/A	Flare Slope LT (%)	N/A	N/A	Flare Slope RT (%)	0.0
N/A	Flare Traversable LT?	N/A	N/A	Flare Traversable RT?	N/A
N/A	Landing Length (in)	0.0	N/A	DWS Provided?	N/A
N/A	Landing Width (in)	0.0	N/A	DWS Contrast?	N/A
N/A	Landing Slope (%)	0.0	N/A	DWS Length (in)	N/A
N/A	Landing X Slope (%)	0.0	N/A	DWS Full Width?	N/A
N/A	Landing Curb? (Y/N)	N/A	N/A	DWS Offset LT (in)	N/A
N/A	Shared Landing?	N/A	N/A	DWS Offset RT (in)	N/A
N/A	Gutter Ponding?	0.0	N/A	Gutter Slope (%)	N/A
N/A	Gutter Lip Ht (in)	0.0	N/A	Gutter X Slope (%)	N/A
N/A	Painted X Walk1?	Yes		Road Slope (%)	2.3
	X Walk 1 Direction	To NW		Road X Slope (%)	3.4
	X Walk 1 Width (in)	110.0		Clear Space?	N/A

X Walk 1 Slope (%)	2.3	N/A	Clear Space to XWalk (in)	N/A
	X Walk 1 X Slope (%)	3.4	N/A	Storm Grate/Utility Hazard?	N/A
N/A	Ramp inside XWalk1?	Yes		Storm Grate/Utility Type	
N/A	Any Obstructions?	N/A			N/A
	Obstruction Type		Yes	Surface Condition? (G/P)	Good
			N/A	Curb Slope (%)	0.9

**Remove & Replace Entire Ramp.**

Total Cost: \$ **1600.00**
