# Access Compliance Report

## Public Rights-of-Way (Curb Ramps)

| Intersection ID: 51074 | Main Street: HEATHCOTT_CR | Cross Street: SILVER_GLEN_LN | Location: SW |
| ADA ID: B0F3C2DA1F19 | Ramp Type: PerpDiag | Initial Pass/Fail: Fail | Overall Compliance: No |

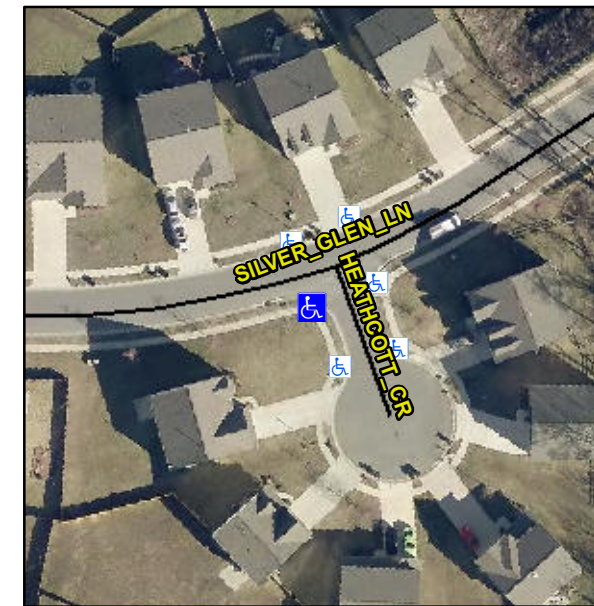
**Not Found, R304.2.2**

| Compliance | Description | Data | Compliance | Description | Data |
|---|---|---|---|---|---|
| N/A | Ramp Length (in) | 47.0 | No | Ramp Slope (%) | 10.7 |

**Remove & Replace Curb Ramp With Two New Directional Ramps or Equivalent.**

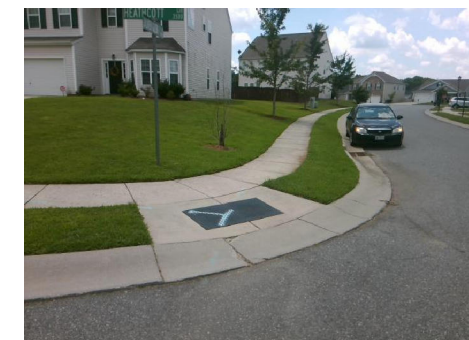
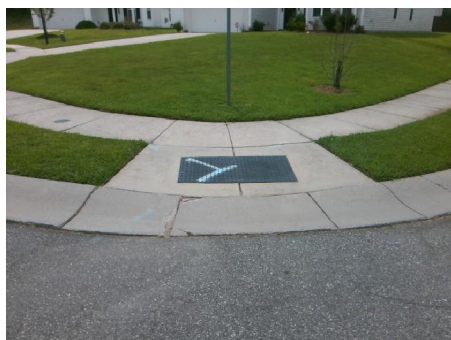
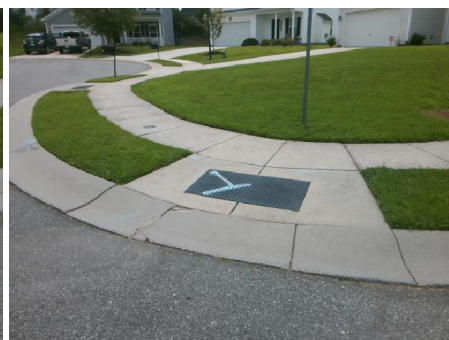
| Compliance | Description | Data | Compliance | Description | Data |
|---|---|---|---|---|---|
| | | Yes | | Surface Condition? (G/P) | Good |
