# Access Compliance Report

## Public Rights-of-Way

### (Curb Ramps)

| Intersection ID: 54364 | Main Street: GANNON_DR | Cross Street: BEREWICK_TOWN_CENTER_DR | Location: SW |

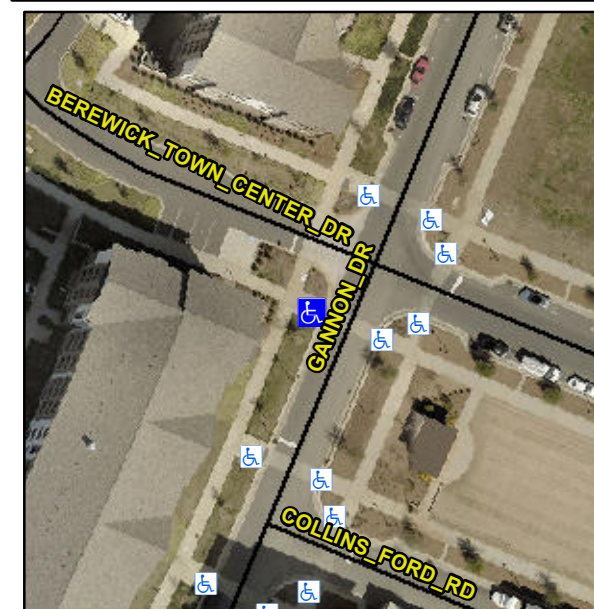
| Compliance | Description | Data | Compliance | Description | Data |
|---|---|---|---|---|---|
| No | Landing Slope (%) | 4.2 | Yes | DWS Length (in) | 24.0 |

**Remove & Replace Landing.**
