Access Compliance Report

Public Rights-of-Way

(Curb Ramps)

Intersection ID: 45296	Main Street: ANN_MARIE_DR	Cross Street: PRESIDENTS_CT	Location: SW
ADA ID: B10574F2FEA5	Ramp Type: PerpDiag	Initial Pass/Fail: Fail	Overall Compliance: No
Codes/Mitigation Info/Possible Solution		Field Measurements/Component Compliance	
Severity Score: 46.25

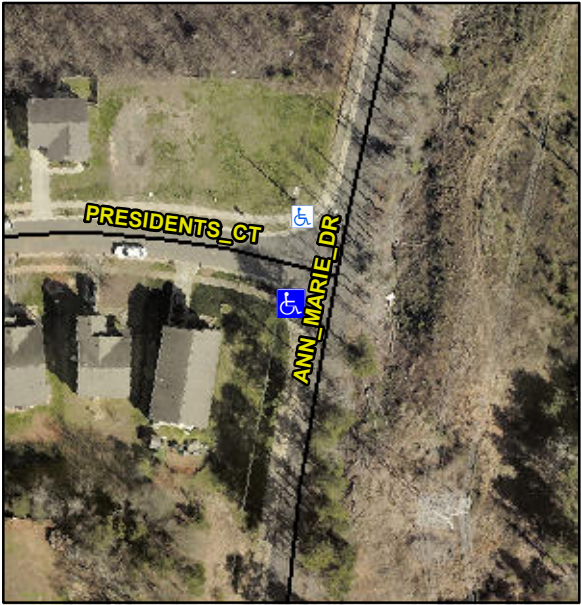
Possible Solutions:		Compliance	Description	Data	Compliance	Description	Data
	Remove & Replace Curb Ramp With Two New Directional Ramps or Equivalent.		N/A	Ramp Length (in)	44.0	No	Ramp Slope (%)	10.9
<p>Surveyor Notes:</p> <p>N/A</p> <p>PROW/ADA:</p> <p>Not Found, R304.5.1, R304.2.2, R304.5.3</p>			No	Ramp Width (in)	47.0	No	Ramp XSlope (%)	10.7
			N/A	Flare Type LT	N/A	N/A	Flare Type RT	N/A
			N/A	Flare Slope LT (%)	N/A	N/A	Flare Slope RT (%)	N/A
			N/A	Flare Traversable LT?	N/A	N/A	Flare Traversable RT?	N/A
			N/A	Landing Length (in)	N/A	N/A	DWS Provided?	N/A
			N/A	Landing Width (in)	N/A	N/A	DWS Contrast?	N/A
			N/A	Landing Slope (%)	N/A	N/A	DWS Length (in)	N/A
			N/A	Landing X Slope (%)	N/A	N/A	DWS Full Width?	N/A
			N/A	Landing Curb? (Y/N)	N/A	N/A	DWS Offset (in)	N/A
			N/A	Shared Landing?	N/A			
			N/A	Gutter Ponding?	N/A	N/A	Gutter Slope (%)	N/A
			N/A	Gutter Lip Ht (in)	N/A	N/A	Gutter X Slope (%)	N/A

N/A	Painted X Walk1?	No	N/A	Painted X Walk2?	No
				X Walk 1 Direction	To E		X Walk 2 Direction	To N
			N/A	X Walk 1 Width (in)	N/A	N/A	X Walk 2 Width (in)	N/A
				X Walk 1 Slope (%)	2.1		X Walk 2 Slope (%)	7.0
				X Walk 1 X Slope (%)	9.5		X Walk 2 X Slope (%)	5.4
			N/A	Ramp inside XWalk1?	N/A	N/A	Ramp inside XWalk2?	N/A
				Road Slope (%)	8.2	N/A	Clear Space?	N/A
				Road X Slope (%)	3.3	N/A	Clear Space to XWalk (in)	N/A
			N/A	Any Obstructions?	N/A	N/A	Storm Grate/Utility Hazard?	N/A
				Obstruction Type			Storm Grate/Utility Type	
						N/A		N/A
						Yes	Surface Condition? (G/P)	Good
