# Access Compliance Report

## Public Rights-of-Way

### (Curb Ramps)

Intersection ID: 6203	Main Street: CRANDON_DR	Cross Street: PEACHWOOD_DR	Location: NE
ADA ID: B10F1C7D1A4D	Ramp Type: PerpDiag	Initial Pass/Fail: Fail	Overall Compliance: No
Severity Score: 1.25			
Codes/Mitigation Info/Possible Solution		Field Measurements/Component Compliance

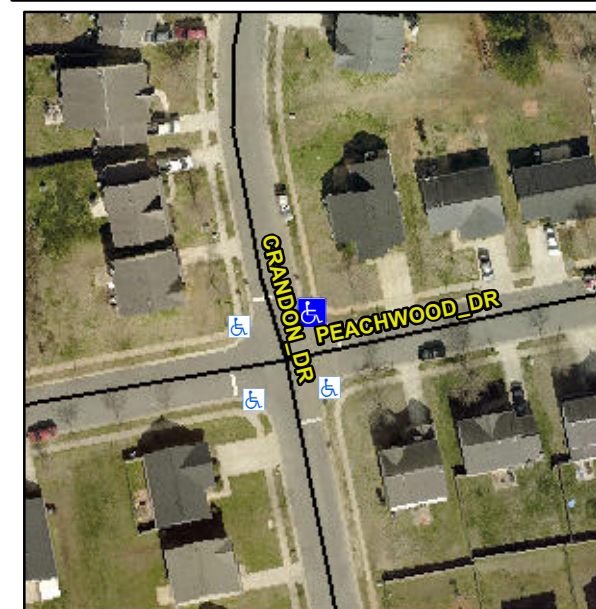
Compliance	Description	Data	Compliance	Description	Data
N/A	Ramp Length (in)	50.0	Yes	Ramp Slope (%)	7.3
Yes	Ramp Width (in)	72.0	No	Ramp XSlope (%)	4.1
N/A	Flare Type LT	N/A	N/A	Flare Type RT	N/A
N/A	Flare Slope LT (%)	N/A	N/A	Flare Slope RT (%)	N/A
N/A	Flare Traversable LT?	N/A	N/A	Flare Traversable RT?	N/A
N/A	Landing Length (in)	N/A	N/A	DWS Provided?	N/A
N/A	Landing Width (in)	N/A	N/A	DWS Contrast?	N/A
N/A	Landing Slope (%)	N/A	N/A	DWS Length (in)	N/A
N/A	Landing X Slope (%)	N/A	N/A	DWS Full Width?	N/A
N/A	Landing Curb? (Y/N)	N/A	N/A	DWS Offset (in)	N/A
N/A	Shared Landing?	N/A			
N/A	Gutter Ponding?	N/A	N/A	Gutter Slope (%)	N/A
N/A	Gutter Lip Ht (in)	N/A	N/A	Gutter X Slope (%)	N/A
N/A	Painted X Walk1?	No	N/A	Painted X Walk2?	No
	X Walk 1 Direction	To W		X Walk 2 Direction	To S
N/A	X Walk 1 Width (in)	N/A	N/A	X Walk 2 Width (in)	N/A
	X Walk 1 Slope (%)	1.5		X Walk 2 Slope (%)	3.5
	X Walk 1 X Slope (%)	2.5		X Walk 2 X Slope (%)	0.9

N/A	Ramp inside XWalk1?	N/A	N/A	Ramp inside XWalk2?	N/A
	Road Slope (%)	3.1	N/A	Clear Space?	N/A
	Road X Slope (%)	0.2	N/A	Clear Space to XWalk (in)	N/A
N/A	Any Obstructions?	N/A	N/A	Storm Grate/Utility Hazard?	N/A
	Obstruction Type			Storm Grate/Utility Type	
		N/A			N/A
		Yes		Surface Condition? (G/P)	Good

**Remove & Replace Curb Ramp With Two New Directional Ramps or Equivalent.**
