Access Compliance Report

Public Rights-of-Way

(Curb Ramps)

Intersection ID: N/A	Main Street: SPEER_BV	Cross Street: NATIONAL_AV	Location: NW
ADA ID: B11529A23042	Ramp Type: Perp	Initial Pass/Fail: Fail	Overall Compliance: No
Severity Score: 12.5			
Codes/Mitigation Info/Possible Solution		Field Measurements/Component Compliance

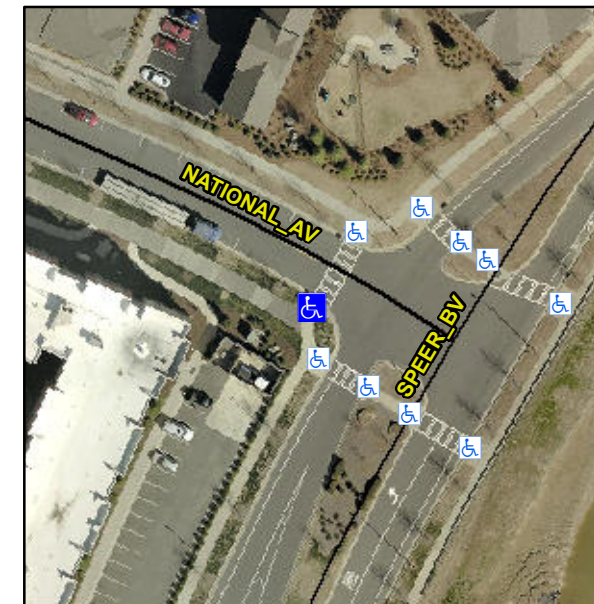
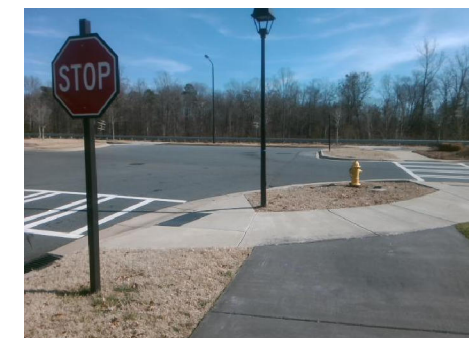
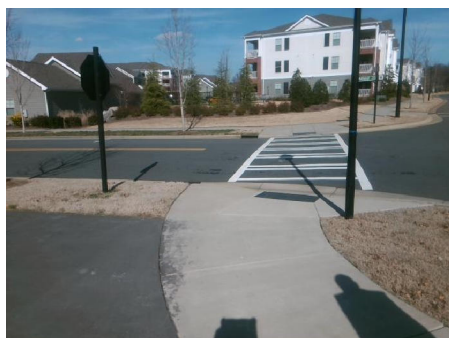
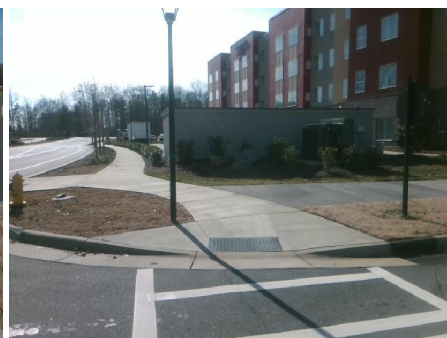
Compliance	Description	Data	Compliance	Description	Data
N/A	Ramp Length (in)	67.0	No	Ramp Slope (%)	8.6
Yes	Ramp Width (in)	48.0	Yes	Ramp XSlope (%)	1.7
N/A	Flare Type LT	N/A	N/A	Flare Type RT	N/A
N/A	Flare Slope LT (%)	N/A	N/A	Flare Slope RT (%)	N/A
N/A	Flare Traversable LT?	N/A	N/A	Flare Traversable RT?	N/A
N/A	Landing Length (in)	N/A	N/A	DWS Provided?	N/A
N/A	Landing Width (in)	N/A	N/A	DWS Contrast?	N/A
N/A	Landing Slope (%)	N/A	N/A	DWS Length (in)	N/A
N/A	Landing X Slope (%)	N/A	N/A	DWS Full Width?	N/A
N/A	Landing Curb? (Y/N)	N/A	N/A	DWS Offset (in)	N/A
N/A	Shared Landing?	N/A			
N/A	Gutter Ponding?	N/A	N/A	Gutter Slope (%)	N/A
N/A	Gutter Lip Ht (in)	N/A	N/A	Gutter X Slope (%)	N/A
N/A	Painted X Walk1?	Yes	N/A	Painted X Walk2?	N/A
	X Walk 1 Direction	To NE		X Walk 2 Direction	N/A
N/A	X Walk 1 Width (in)	112.0	N/A	X Walk 2 Width (in)	N/A
	X Walk 1 Slope (%)	1.7		X Walk 2 Slope (%)	N/A
	X Walk 1 X Slope (%)	3.8		X Walk 2 X Slope (%)	N/A

N/A	Ramp inside XWalk1?	Yes	N/A	Ramp inside XWalk2?	N/A
	Road Slope (%)	N/A	N/A	Clear Space?	N/A
	Road X Slope (%)	N/A	N/A	Clear Space to XWalk (in)	N/A
N/A	Any Obstructions?	N/A	N/A	Storm Grate/Utility Hazard?	N/A
	Obstruction Type			Storm Grate/Utility Type	
		N/A			N/A
		Yes		Surface Condition? (G/P)	Good

Remove & Replace Entire Ramp.

R304.2.2
