Access Compliance Report

Public Rights-of-Way

(Curb Ramps)

Intersection ID: 28364	Main Street: HIGHLANDS_CROSSING_DR	Cross Street: SOUTHAMPTON_COMMONS_DR	Location: SW
ADA ID: B12185095E22	Ramp Type: PerpDiag	Initial Pass/Fail: Fail	Overall Compliance: No
Severity Score: 17.5			
Codes/Mitigation Info/Possible Solution		Field Measurements/Component Compliance

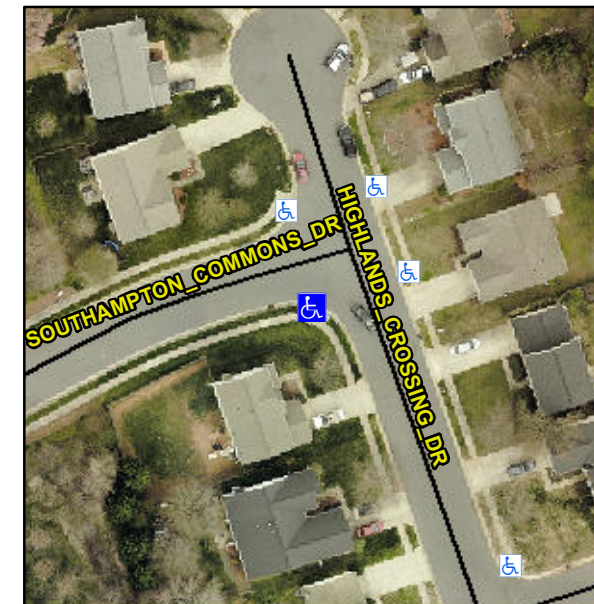
Not Found, R304.5.1

Compliance	Description	Data	Compliance	Description	Data
N/A	Ramp Length (in)	47.0	Yes	Ramp Slope (%)	7.7
No	Ramp Width (in)	35.0	Yes	Ramp XSlope (%)	0.9
N/A	Flare Type LT	N/A	N/A	Flare Type RT	N/A
N/A	Flare Slope LT (%)	N/A	N/A	Flare Slope RT (%)	N/A
N/A	Flare Traversable LT?	N/A	N/A	Flare Traversable RT?	N/A
N/A	Landing Length (in)	N/A	N/A	DWS Provided?	N/A
N/A	Landing Width (in)	N/A	N/A	DWS Contrast?	N/A
N/A	Landing Slope (%)	N/A	N/A	DWS Length (in)	N/A
N/A	Landing X Slope (%)	N/A	N/A	DWS Full Width?	N/A
N/A	Landing Curb? (Y/N)	N/A	N/A	DWS Offset (in)	N/A
N/A	Shared Landing?	N/A			
N/A	Gutter Ponding?	N/A	N/A	Gutter Slope (%)	N/A
N/A	Gutter Lip Ht (in)	N/A	N/A	Gutter X Slope (%)	N/A
N/A	Painted X Walk1?	No	N/A	Painted X Walk2?	No
	X Walk 1 Direction	To E		X Walk 2 Direction	To N
N/A	X Walk 1 Width (in)	N/A	N/A	X Walk 2 Width (in)	N/A
	X Walk 1 Slope (%)	5.0		X Walk 2 Slope (%)	3.8
	X Walk 1 X Slope (%)	2.3		X Walk 2 X Slope (%)	4.0

N/A	Ramp inside XWalk1?	N/A	N/A	Ramp inside XWalk2?	N/A
	Road Slope (%)	0.7	N/A	Clear Space?	N/A
	Road X Slope (%)	3.5	N/A	Clear Space to XWalk (in)	N/A
N/A	Any Obstructions?	N/A	N/A	Storm Grate/Utility Hazard?	N/A
	Obstruction Type			Storm Grate/Utility Type	
		N/A			N/A
			Yes	Surface Condition? (G/P)	Good

Possible Solutions:

Remove & Replace Curb Ramp With Two New Directional Ramps or Equivalent.

Total Cost: \$ 3200.00
