# Access Compliance Report

## Public Rights-of-Way

### (Curb Ramps)

Intersection ID: 12958	Main Street: E_3RD_ST	Cross Street: S_DAVIDSON_ST	Location: S
ADA ID: B12A82929244	Ramp Type: PerpDiag	Initial Pass/Fail: Fail	Overall Compliance: No
		Severity Score: 12.5

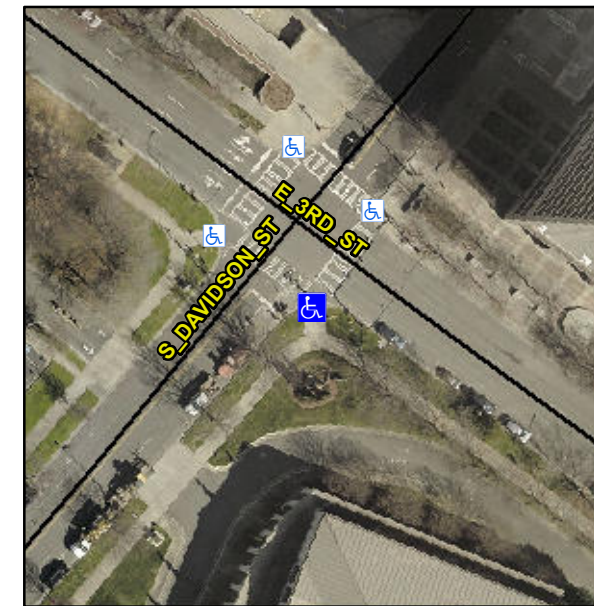
Compliance	Description	Data	Compliance	Description	Data
N/A	Ramp Length (in)	108.0	Yes	Ramp Slope (%)	4.0
Yes	Ramp Width (in)	60.0	No	Ramp XSlope (%)	5.1
N/A	Flare Type LT	N/A	N/A	Flare Type RT	N/A
N/A	Flare Slope LT (%)	N/A	N/A	Flare Slope RT (%)	N/A
N/A	Flare Traversable LT?	N/A	N/A	Flare Traversable RT?	N/A
N/A	Landing Length (in)	N/A	N/A	DWS Provided?	N/A
N/A	Landing Width (in)	N/A	N/A	DWS Contrast?	N/A
N/A	Landing Slope (%)	N/A	N/A	DWS Length (in)	N/A
N/A	Landing X Slope (%)	N/A	N/A	DWS Full Width?	N/A
N/A	Landing Curb? (Y/N)	N/A	N/A	DWS Offset (in)	N/A
N/A	Shared Landing?	N/A			
N/A	Gutter Ponding?	N/A	N/A	Gutter Slope (%)	N/A
N/A	Gutter Lip Ht (in)	N/A	N/A	Gutter X Slope (%)	N/A
N/A	Painted X Walk1?	Yes	N/A	Painted X Walk2?	Yes
	X Walk 1 Direction	To NE		X Walk 2 Direction	To NW
N/A	X Walk 1 Width (in)	128.0	N/A	X Walk 2 Width (in)	114.0
	X Walk 1 Slope (%)	1.4		X Walk 2 Slope (%)	3.5
	X Walk 1 X Slope (%)	3.6		X Walk 2 X Slope (%)	0.6

N/A	Ramp inside XWalk1?	Yes	N/A	Ramp inside XWalk2?	Yes
	Road Slope (%)	2.9	N/A	Clear Space?	N/A
	Road X Slope (%)	4.6	N/A	Clear Space to XWalk (in)	N/A
N/A	Any Obstructions?	N/A	N/A	Storm Grate/Utility Hazard?	N/A
	Obstruction Type			Storm Grate/Utility Type	
		N/A			N/A
		Yes		Surface Condition? (G/P)	Good

**Remove & Replace Curb Ramp With Two New Directional Ramps or Equivalent.**

**R304.5.3**
