## **Access Compliance Report Public Rights-of-Way** (Curb Ramps)

Intersection ID: 10033483 Main Street: OLD\_PINEVILLE\_RD Cross Street: N/A Location: NW **Overall Compliance: No Severity Score: ADA ID: B12B7BEA4230** Ramp Type: Directional1 Initial Pass/Fail: Fail 1.25

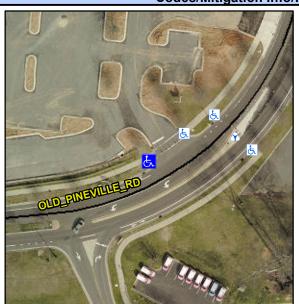
Field Measurements/Component Compliance							
Compli	ance Description	Data	Compli	ance Description	Data		
N/A	Ramp Length (in)	68.0	N/A	Grade Break?	N/A		
Yes	Ramp Width (in)	67.0	N/A	Grade Break Slope (%)	0.0		
Yes	Ramp Slope (%)	4.2	N/A	Grade Break XSlope (%)	0.0		
No	Ramp XSlope (%)	3.8					
N/A	Flare Type LT	N/A	N/A	Flare Type RT	N/A		
N/A	Flare Slope LT (%)	N/A	N/A	Flare Slope RT (%)	0.0		
N/A	Flare Traversable LT?	N/A	N/A	Flare Traversable RT?	N/A		
N/A	Landing Length (in)	0.0	N/A	DWS Provided?	N/A		
N/A	Landing Width (in)	0.0	N/A	DWS Contrast?	N/A		
N/A	Landing Slope (%)	0.0	N/A	DWS Length (in)	N/A		
N/A	Landing X Slope (%)	0.0	N/A	DWS Full Width?	N/A		
N/A	Landing Curb? (Y/N)	N/A	N/A	DWS Offset LT (in)	N/A		
N/A	Shared Landing?	N/A	N/A	DWS Offset RT (in)	N/A		
N/A	Gutter Ponding?	0.0	N/A	Gutter Slope (%)	N/A		
N/A	Gutter Lip Ht (in)	0.0	N/A	Gutter X Slope (%)	N/A		
N/A	Painted X Walk1?	Yes		Road Slope (%)	4.1

Possible Solutions:
Remove & Replace Entire Ramp.
Surveyor Notes:
N/A
PROW/ADA:
R304.5.3
i
