# Access Compliance Report

## Public Rights-of-Way

### (Curb Ramps)

Intersection ID: 28112	Main Street: PROVIDENCE_RD	Cross Street: BELICOURT_DR	Location: SE
ADA ID: B1413EB04AF4	Ramp Type: Para	Initial Pass/Fail: Fail	Overall Compliance: No
Severity Score: 12.5			
Codes/Mitigation Info/Possible Solution		Field Measurements/Component Compliance

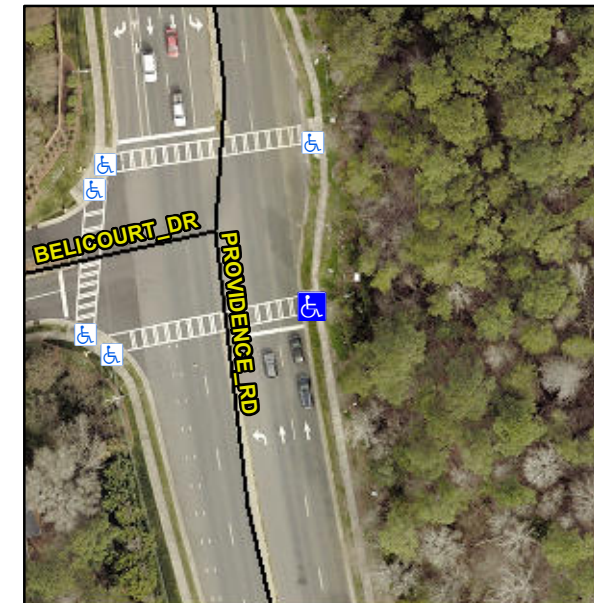
Surveyor Notes:

**RT RP < 5%**

PROW/ADA:

**R304.3.2**

Compliance	Description	Data	Compliance	Description	Data
N/A	Ramp Length LT (in)	77.0	N/A	Ramp Length RT (in)	70.0
Yes	Ramp Width LT (in)	59.0	Yes	Ramp Width RT (in)	59.0
No	Ramp Slope LT (%)	9.1	Yes	Ramp Slope RT (%)	2.1
Yes	Ramp XSlope LT (%)	1.6	Yes	Ramp XSlope RT (%)	1.5
N/A	Landing Length (in)	N/A	N/A	DWS Provided?	N/A
N/A	Landing Width (in)	N/A	N/A	DWS Contrast?	N/A
N/A	Landing Slope (%)	N/A	N/A	DWS Length (in)	N/A
N/A	Landing X Slope (%)	N/A	N/A	DWS Full Width?	N/A
N/A	Landing Curb? (Y/N)	N/A	N/A	DWS Offset (in)	N/A
N/A	Shared Landing?	N/A			
N/A	Gutter Ponding?	N/A	N/A	Gutter Slope (%)	N/A
N/A	Gutter Lip Ht (in)	N/A	N/A	Gutter X Slope (%)	N/A
N/A	Painted X Walk1?	Yes	N/A	Painted X Walk2?	N/A
	X Walk 1 Direction	To W		X Walk 2 Direction	N/A
N/A	X Walk 1 Width (in)	108.0	N/A	X Walk 2 Width (in)	N/A
	X Walk 1 Slope (%)	5.6		X Walk 2 Slope (%)	N/A
	X Walk 1 X Slope (%)	3.6		X Walk 2 X Slope (%)	N/A
N/A	Ramp inside XWalk1?	Yes	N/A	Ramp inside XWalk2?	N/A

Road Slope (%)	N/A	N/A	Clear Space?	N/A
	Road X Slope (%)	N/A	N/A	Clear Space to XWalk (in)	N/A
N/A	Any Obstructions?	N/A	N/A	Storm Grate/Utility Hazard?	N/A
	Obstruction Type			Storm Grate/Utility Type	
		N/A			N/A
			Yes	Surface Condition? (G/P)	Good
			N/A	Curb Slope (%)	15.7

Possible Solutions:

**Remove & Replace Entire Ramp.**

Total Cost: \$ 1600.00
