Access Compliance Report

Public Rights-of-Way

(Curb Ramps)

Intersection ID: 29343	Main Street: ELIZABETH_RD	Cross Street: BIRCHSTONE_LN	Location:	N
ADA ID: B1442B12842F	Ramp Type: BlendTrans1	Initial Pass/Fail: Fail	Overall Compliance: No	Severity Score: 33.75

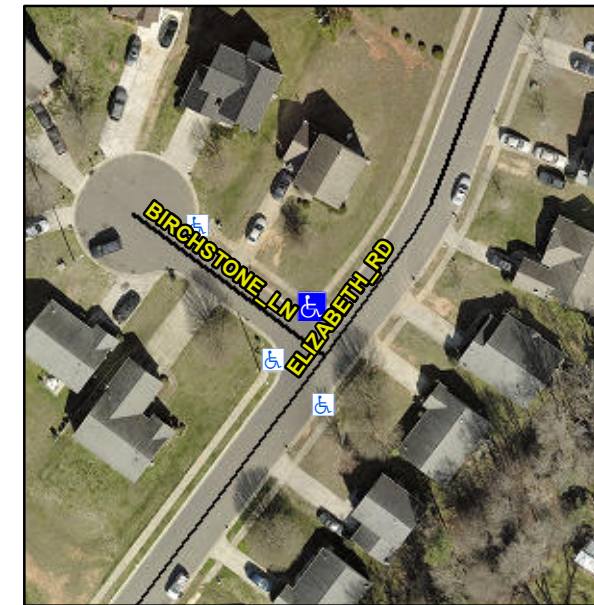
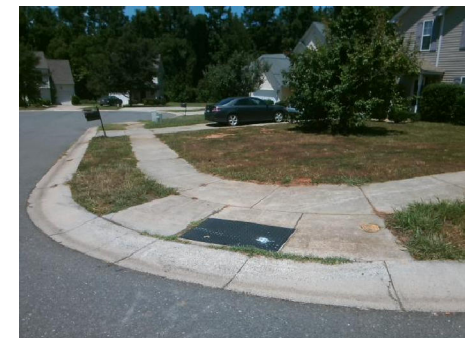
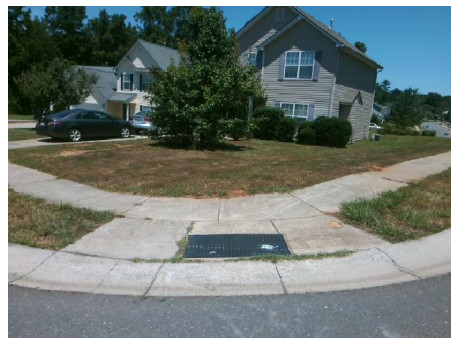
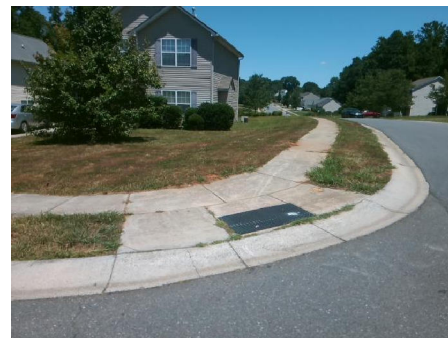
Not Found, R304.5.1, R304.5.3

Compliance	Description	Data	Compliance	Description	Data
N/A	Ramp Length (in)	47.0	Yes	BlendTrans Slope (%)	2.8
No	Ramp Width (in)	42.0	No	BlendTrans XSlope (%)	7.3
N/A	Flare Type LT	N/A	N/A	Flare Type RT	N/A
N/A	Flare Slope LT (%)	N/A	N/A	Flare Slope RT (%)	N/A
N/A	Flare Traversable LT?	N/A	N/A	Flare Traversable RT?	N/A
N/A	Landing Length (in)	N/A	N/A	DWS Provided?	N/A
N/A	Landing Width (in)	N/A	N/A	DWS Contrast?	N/A
N/A	Landing Slope (%)	N/A	N/A	DWS Length (in)	N/A
N/A	Landing X Slope (%)	N/A	N/A	DWS Full Width?	N/A
N/A	Landing Curb? (Y/N)	N/A	N/A	DWS Offset (in)	N/A
N/A	Shared Landing?	N/A			
N/A	Gutter Ponding?	N/A	N/A	Gutter Slope (%)	N/A
N/A	Gutter Lip Ht (in)	N/A	N/A	Gutter X Slope (%)	N/A
N/A	Painted X Walk1?	No	N/A	Painted X Walk2?	No
	X Walk 1 Direction	To SW		X Walk 2 Direction	To SE
	X Walk 1 Width (in)	N/A		X Walk 2 Width (in)	N/A
	X Walk 1 Slope (%)	0.3		X Walk 2 Slope (%)	5.3
	X Walk 1 X Slope (%)	7.4		X Walk 2 X Slope (%)	2.1

N/A	Ramp inside XWalk1?	N/A	N/A	Ramp inside XWalk2?	N/A
	Road Slope (%)	7.0		Clear Space?	N/A
	Road X Slope (%)	3.1	N/A	Clear Space to XWalk (in)	N/A
N/A	Any Obstructions?	N/A	N/A	Storm Grate/Utility Hazard?	N/A
	Obstruction Type			Storm Grate/Utility Type	
		N/A			N/A
			Yes	Surface Condition? (G/P)	Good
			No	Curb Slope (%)	16.6

Remove & Replace Curb Ramp With Two New Directional Ramps or Equivalent.
