# Access Compliance Report

## Public Rights-of-Way

| Intersection ID: 48447 | Main Street: ALVARADO_WY | Cross Street: DUSTY_SADDLE_RD | Location: SE |
| ADA ID: B14F129BABD1 | Ramp Type: PerpDiag | Initial Pass/Fail: Fail | Overall Compliance: No |

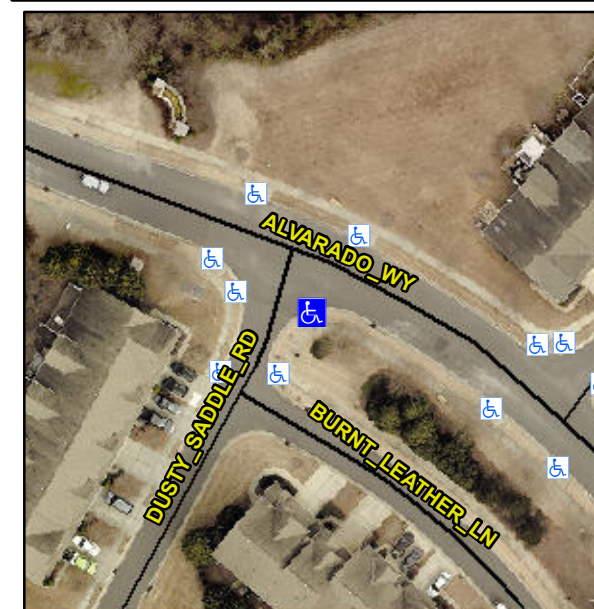
**Not Found, R304.5.1, R304.5.3**

| Compliance | Description | Data | Compliance | Description | Data |
|---|---|---|---|---|---|
| N/A | Ramp Length (in) | 71.0 | Yes | Ramp Slope (%) | 6.1 |
| No | Ramp Width (in) | 44.5 | No | Ramp XSlope (%) | 5.3 |

**Remove & Replace Curb Ramp With Two New Directional Ramps or Equivalent.**
