Access Compliance Report

Public Rights-of-Way

(Curb Ramps)

Intersection ID: 3062	Main Street: LOGANVILLE_DR	Cross Street: BENFIELD_RD	Location:	N
ADA ID: B159CBA31361	Ramp Type: Perp	Initial Pass/Fail: Fail	Overall Compliance: No	Severity Score: 12.5
Codes/Mitigation Info/Possible Solution		Field Measurements/Component Compliance

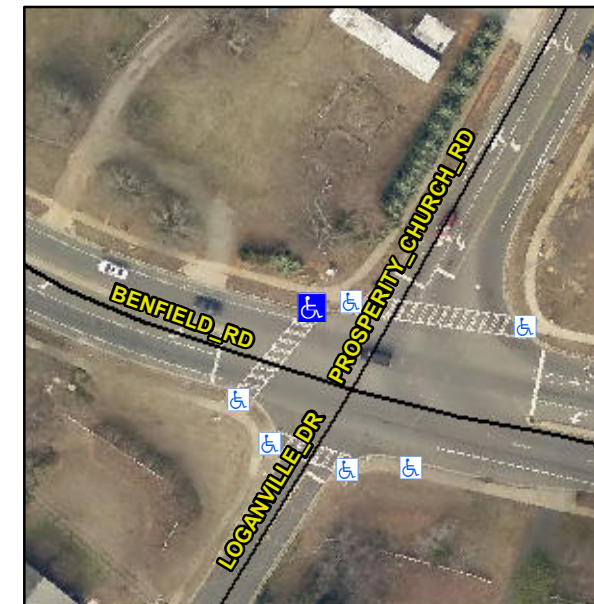
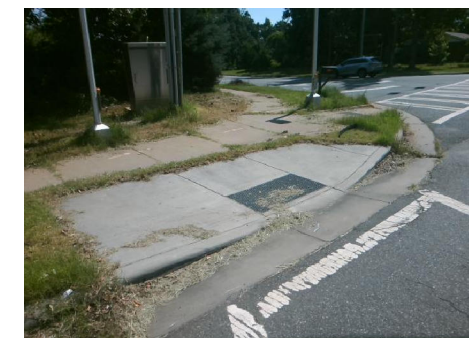
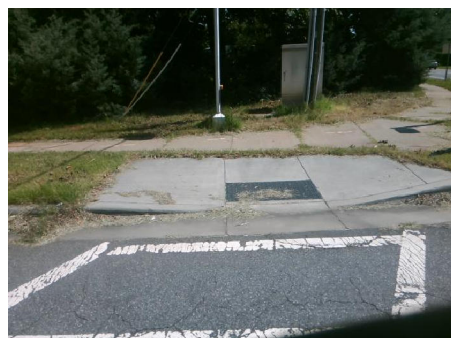
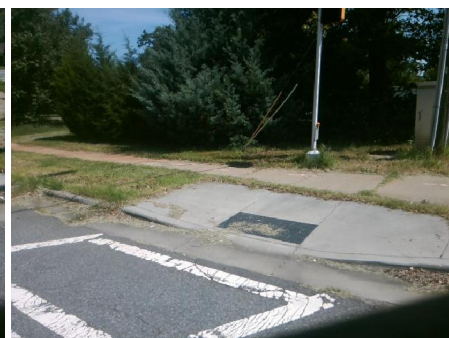
Compliance	Description	Data	Compliance	Description	Data
N/A	Ramp Length (in)	74.5	No	Ramp Slope (%)	11.3
Yes	Ramp Width (in)	48.0	Yes	Ramp XSlope (%)	1.6
N/A	Flare Type LT	N/A	N/A	Flare Type RT	N/A
N/A	Flare Slope LT (%)	N/A	N/A	Flare Slope RT (%)	N/A
N/A	Flare Traversable LT?	N/A	N/A	Flare Traversable RT?	N/A
N/A	Landing Length (in)	N/A	N/A	DWS Provided?	N/A
N/A	Landing Width (in)	N/A	N/A	DWS Contrast?	N/A
N/A	Landing Slope (%)	N/A	N/A	DWS Length (in)	N/A
N/A	Landing X Slope (%)	N/A	N/A	DWS Full Width?	N/A
N/A	Landing Curb? (Y/N)	N/A	N/A	DWS Offset (in)	N/A
N/A	Shared Landing?	N/A			
N/A	Gutter Ponding?	N/A	N/A	Gutter Slope (%)	N/A
N/A	Gutter Lip Ht (in)	N/A	N/A	Gutter X Slope (%)	N/A
N/A	Painted X Walk1?	Yes	N/A	Painted X Walk2?	N/A
	X Walk 1 Direction	To SW		X Walk 2 Direction	N/A
N/A	X Walk 1 Width (in)	108.5	N/A	X Walk 2 Width (in)	N/A
	X Walk 1 Slope (%)	1.1		X Walk 2 Slope (%)	N/A
	X Walk 1 X Slope (%)	1.0		X Walk 2 X Slope (%)	N/A

N/A	Ramp inside XWalk1?	Yes	N/A	Ramp inside XWalk2?	N/A
	Road Slope (%)	N/A	N/A	Clear Space?	N/A
	Road X Slope (%)	N/A	N/A	Clear Space to XWalk (in)	N/A
N/A	Any Obstructions?	N/A	N/A	Storm Grate/Utility Hazard?	N/A
	Obstruction Type			Storm Grate/Utility Type	
		N/A			N/A
			Yes	Surface Condition? (G/P)	Good

Remove & Replace Entire Ramp.

R304.2.2
