# Access Compliance Report

## Public Rights-of-Way

### (Curb Ramps)

| Intersection ID: 29150 | Main Street: DEATON_HILL_DR | Cross Street: HIGHLAND_PARK_DR | Location: SE |

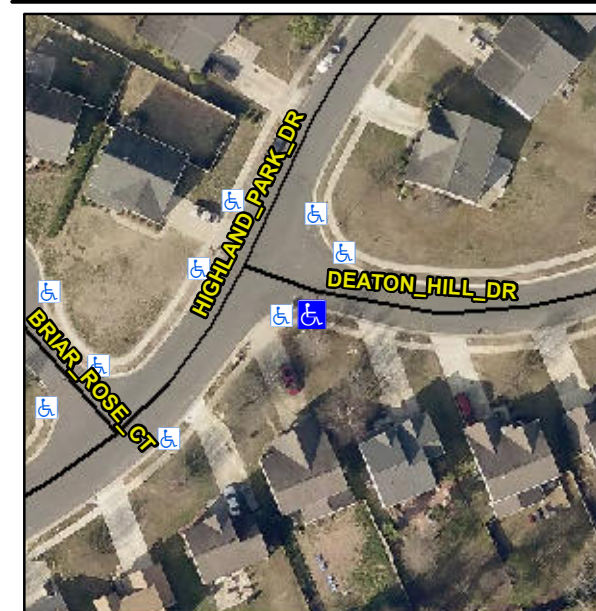
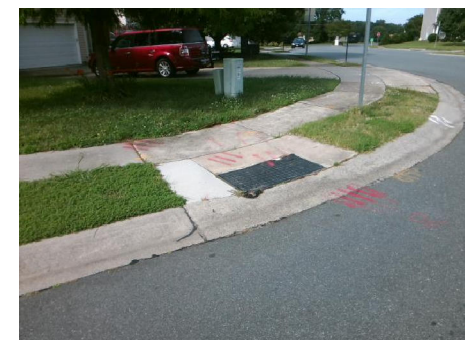
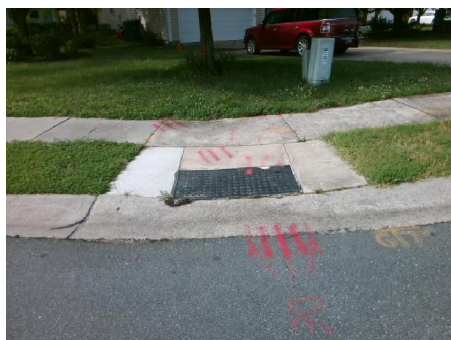
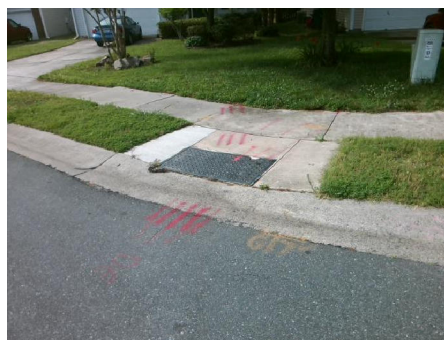
| ADA ID: B16154F298DB | Ramp Type: BlendTrans1 | Initial Pass/Fail: Pass | Overall Compliance: No |

**DWS DETACHED**

**Not Found, R304.5.3, R304.2.1, R304.2.2-Perp, R304.3.2-Para, R305.1.4, R302.7.2**

**Remove & Replace Curb Ramp With Two New Directional Ramps or Equivalent. Remove & Replace Gutter.**
