Access Compliance Report

Public Rights-of-Way

(Curb Ramps)

Intersection ID: 16805	Main Street: N_SHARON_AMITY_RD	Cross Street: KELLY_ST	Location: SW
ADA ID: B1616408FF33	Ramp Type: ParaDiag	Initial Pass/Fail: Fail	Overall Compliance: No
Severity Score: 37.5			
Codes/Mitigation Info/Possible Solution		Field Measurements/Component Compliance

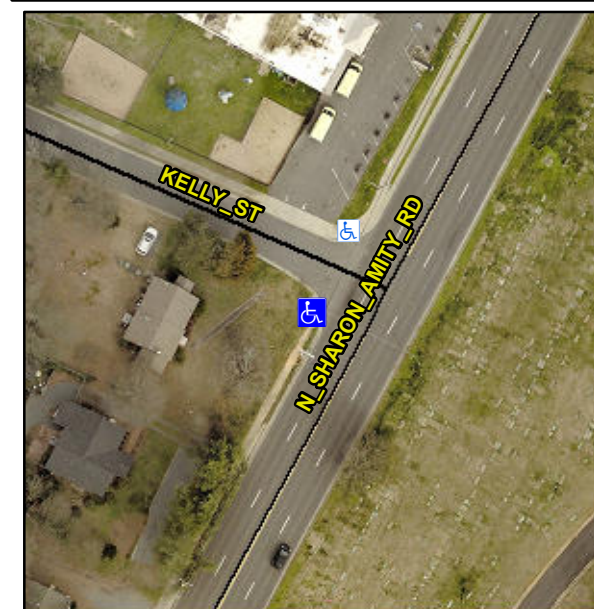
ASP LIP 2.0

PROW/ADA:

R304.3.2, R304.5.3

Compliance	Description	Data	Compliance	Description	Data
N/A	Ramp Length LT (in)	54.0	N/A	Ramp Length RT (in)	60.0
Yes	Ramp Width LT (in)	60.0	Yes	Ramp Width RT (in)	60.0
No	Ramp Slope LT (%)	12.6	Yes	Ramp Slope RT (%)	5.8
No	Ramp XSlope LT (%)	5.7	Yes	Ramp XSlope RT (%)	0.6
N/A	Landing Length (in)	N/A	N/A	DWS Provided?	N/A
N/A	Landing Width (in)	N/A	N/A	DWS Contrast?	N/A
N/A	Landing Slope (%)	N/A	N/A	DWS Length (in)	N/A
N/A	Landing X Slope (%)	N/A	N/A	DWS Full Width?	N/A
N/A	Landing Curb? (Y/N)	N/A	N/A	DWS Offset (in)	N/A
N/A	Shared Landing?	N/A			
N/A	Gutter Ponding?	N/A	N/A	Gutter Slope (%)	N/A
N/A	Gutter Lip Ht (in)	N/A	N/A	Gutter X Slope (%)	N/A
N/A	Painted X Walk1?	No	N/A	Painted X Walk2?	No
	X Walk 1 Direction	To SE		X Walk 2 Direction	To NE
N/A	X Walk 1 Width (in)	N/A	N/A	X Walk 2 Width (in)	N/A
	X Walk 1 Slope (%)	5.4		X Walk 2 Slope (%)	3.3
	X Walk 1 X Slope (%)	3.1		X Walk 2 X Slope (%)	12.0
N/A	Ramp inside XWalk1?	N/A	N/A	Ramp inside XWalk2?	N/A

Road Slope (%)	8.1	N/A	Clear Space?	N/A
	Road X Slope (%)	18.3	N/A	Clear Space to XWalk (in)	N/A
N/A	Any Obstructions?	N/A	N/A	Storm Grate/Utility Hazard?	N/A
	Obstruction Type			Storm Grate/Utility Type	
		N/A			N/A
			Yes	Surface Condition? (G/P)	Good
			N/A	Curb Slope (%)	10.1

Possible Solutions:

Remove & Replace Curb Ramp With Two New Directional Ramps or Equivalent.

Total Cost: \$ 3200.00
