Access Compliance Report

Public Rights-of-Way

(Curb Ramps)

Intersection ID: 47579	Main Street: EVANTON_LOCH_RD	Cross Street: BARRANDS_LN	Location: SW
ADA ID: B163FB7DC1AB	Ramp Type: PerpDiag	Initial Pass/Fail: Fail	Overall Compliance: No
Severity Score: 12.5			
Codes/Mitigation Info/Possible Solution		Field Measurements/Component Compliance

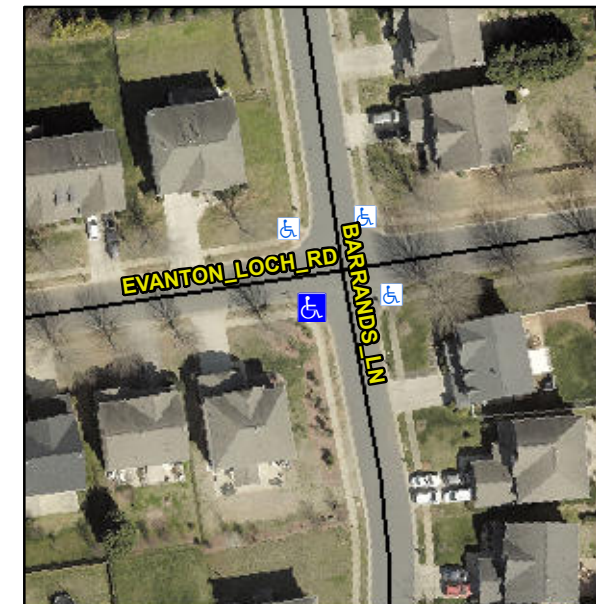
Compliance	Description	Data	Compliance	Description	Data
N/A	Ramp Length (in)	48.0	No	Ramp Slope (%)	8.5
Yes	Ramp Width (in)	48.0	Yes	Ramp XSlope (%)	1.0
N/A	Flare Type LT	N/A	N/A	Flare Type RT	N/A
N/A	Flare Slope LT (%)	N/A	N/A	Flare Slope RT (%)	N/A
N/A	Flare Traversable LT?	N/A	N/A	Flare Traversable RT?	N/A
N/A	Landing Length (in)	N/A	N/A	DWS Provided?	N/A
N/A	Landing Width (in)	N/A	N/A	DWS Contrast?	N/A
N/A	Landing Slope (%)	N/A	N/A	DWS Length (in)	N/A
N/A	Landing X Slope (%)	N/A	N/A	DWS Full Width?	N/A
N/A	Landing Curb? (Y/N)	N/A	N/A	DWS Offset (in)	N/A
N/A	Shared Landing?	N/A			
N/A	Gutter Ponding?	N/A	N/A	Gutter Slope (%)	N/A
N/A	Gutter Lip Ht (in)	N/A	N/A	Gutter X Slope (%)	N/A
N/A	Painted X Walk1?	No	N/A	Painted X Walk2?	No
	X Walk 1 Direction	To E		X Walk 2 Direction	To N
N/A	X Walk 1 Width (in)	N/A	N/A	X Walk 2 Width (in)	N/A
	X Walk 1 Slope (%)	3.6		X Walk 2 Slope (%)	1.8
	X Walk 1 X Slope (%)	1.4		X Walk 2 X Slope (%)	0.5

N/A	Ramp inside XWalk1?	N/A	N/A	Ramp inside XWalk2?	N/A
	Road Slope (%)	1.3	N/A	Clear Space?	N/A
	Road X Slope (%)	4.3	N/A	Clear Space to XWalk (in)	N/A
N/A	Any Obstructions?	N/A	N/A	Storm Grate/Utility Hazard?	N/A
	Obstruction Type			Storm Grate/Utility Type	
		N/A			N/A
		Yes		Surface Condition? (G/P)	Good

Possible Solutions:

Remove & Replace Curb Ramp With Two New Directional Ramps or Equivalent.

R304.2.2
