Access Compliance Report

Public Rights-of-Way

(Curb Ramps)

Intersection ID: 23991	Main Street: MONTIBELLO_DR	Cross Street: RIVER_RIDGE_RD	Location: NW
ADA ID: B16F5B93B96D	Ramp Type: PerpDiag	Initial Pass/Fail: Fail	Overall Compliance: No
Severity Score: 21.25			
Codes/Mitigation Info/Possible Solution		Field Measurements/Component Compliance

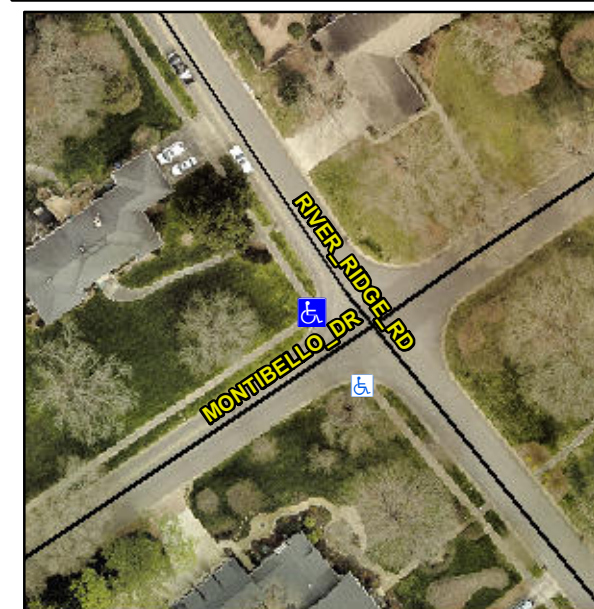
Not Found, R304.5.1, R304.5.3

Compliance	Description	Data	Compliance	Description	Data
N/A	Ramp Length (in)	56.0	Yes	Ramp Slope (%)	5.3
No	Ramp Width (in)	47.0	No	Ramp XSlope (%)	5.2
N/A	Flare Type LT	N/A	N/A	Flare Type RT	N/A
N/A	Flare Slope LT (%)	N/A	N/A	Flare Slope RT (%)	N/A
N/A	Flare Traversable LT?	N/A	N/A	Flare Traversable RT?	N/A
N/A	Landing Length (in)	N/A	N/A	DWS Provided?	N/A
N/A	Landing Width (in)	N/A	N/A	DWS Contrast?	N/A
N/A	Landing Slope (%)	N/A	N/A	DWS Length (in)	N/A
N/A	Landing X Slope (%)	N/A	N/A	DWS Full Width?	N/A
N/A	Landing Curb? (Y/N)	N/A	N/A	DWS Offset (in)	N/A
N/A	Shared Landing?	N/A			
N/A	Gutter Ponding?	N/A	N/A	Gutter Slope (%)	N/A
N/A	Gutter Lip Ht (in)	N/A	N/A	Gutter X Slope (%)	N/A
N/A	Painted X Walk1?	No	N/A	Painted X Walk2?	No
	X Walk 1 Direction	To SE		X Walk 2 Direction	To NE
N/A	X Walk 1 Width (in)	N/A	N/A	X Walk 2 Width (in)	N/A
	X Walk 1 Slope (%)	2.2		X Walk 2 Slope (%)	6.2
	X Walk 1 X Slope (%)	5.5		X Walk 2 X Slope (%)	3.2

N/A	Ramp inside XWalk1?	N/A	N/A	Ramp inside XWalk2?	N/A
	Road Slope (%)	2.4	N/A	Clear Space?	N/A
	Road X Slope (%)	7.0	N/A	Clear Space to XWalk (in)	N/A
N/A	Any Obstructions?	N/A	N/A	Storm Grate/Utility Hazard?	N/A
	Obstruction Type			Storm Grate/Utility Type	
		N/A			N/A
			Yes	Surface Condition? (G/P)	Good

Possible Solutions:

Remove & Replace Curb Ramp With Two New Directional Ramps or Equivalent.
