# Access Compliance Report

## Public Rights-of-Way

### (Curb Ramps)

| Intersection ID: 10147 | Main Street: E_27TH_ST | Cross Street: N_TRYON_ST | Location: W |

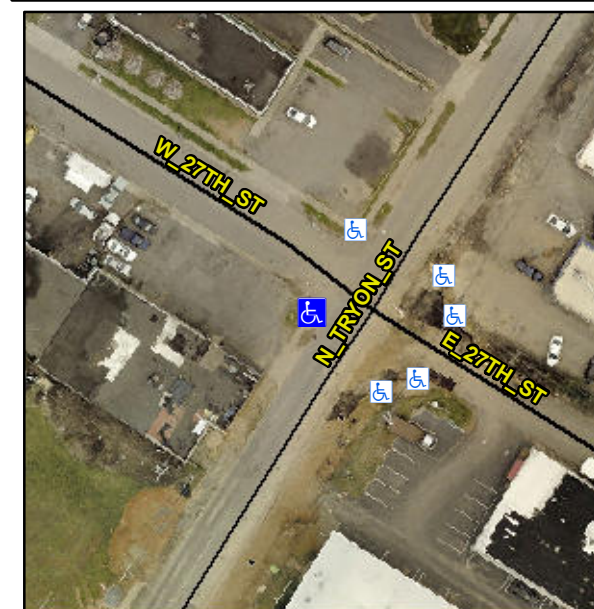
| ADA ID: B1777A5EA5FB | Ramp Type: PerpDiag | Initial Pass/Fail: Fail | Overall Compliance: No |
| Severity Score: 21.25 | | | |

**Not Found, R304.5.1, R304.2.2**

| Compliance | Description | Data | Compliance | Description | Data |
|---|---|---|---|---|---|
| N/A | Ramp Length (in) | 64.0 | No | Ramp Slope (%) | 10.3 |
| No | Ramp Width (in) | 45.0 | Yes | Ramp XSlope (%) | 0.8 |

**Remove & Replace Curb Ramp With Two New Directional Ramps or Equivalent.**

Total Cost: \$ 3200.00
