Access Compliance Report

Public Rights-of-Way

(Curb Ramps)

Intersection ID: N/A	Main Street: AGNEW_DR	Cross Street: SOLAR_WY	Location: NE
ADA ID: B17CD858715F	Ramp Type: BlendTrans1	Initial Pass/Fail: Fail	Overall Compliance: No
		Severity Score: 33.75

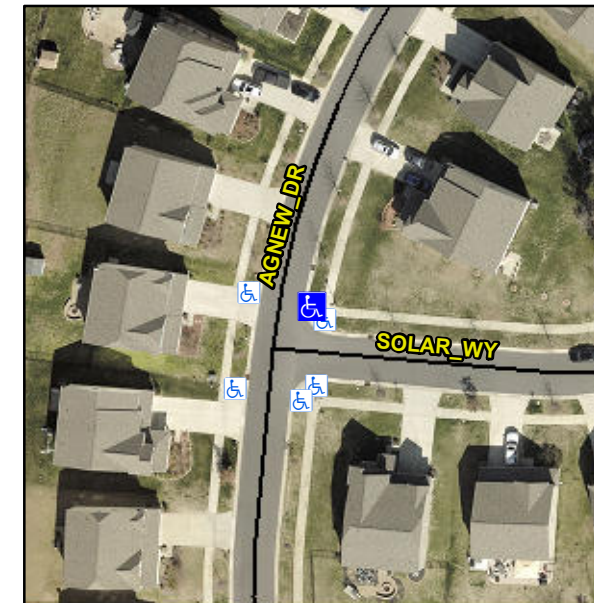
Not Found, R304.5.1, R304.5.3

Compliance	Description	Data	Compliance	Description	Data
N/A	Ramp Length (in)	98.0	Yes	BlendTrans Slope (%)	4.2
No	Ramp Width (in)	39.0	No	BlendTrans XSlope (%)	8.5
N/A	Flare Type LT	N/A	N/A	Flare Type RT	N/A
N/A	Flare Slope LT (%)	N/A	N/A	Flare Slope RT (%)	N/A
N/A	Flare Traversable LT?	N/A	N/A	Flare Traversable RT?	N/A
N/A	Landing Length (in)	N/A	N/A	DWS Provided?	N/A
N/A	Landing Width (in)	N/A	N/A	DWS Contrast?	N/A
N/A	Landing Slope (%)	N/A	N/A	DWS Length (in)	N/A
N/A	Landing X Slope (%)	N/A	N/A	DWS Full Width?	N/A
N/A	Landing Curb? (Y/N)	N/A	N/A	DWS Offset (in)	N/A
N/A	Shared Landing?	N/A			
N/A	Gutter Ponding?	N/A	N/A	Gutter Slope (%)	N/A
N/A	Gutter Lip Ht (in)	N/A	N/A	Gutter X Slope (%)	N/A
N/A	Painted X Walk1?	No	N/A	Painted X Walk2?	N/A
	X Walk 1 Direction	To W		X Walk 2 Direction	N/A
	X Walk 1 Width (in)	N/A		X Walk 2 Width (in)	N/A
	X Walk 1 Slope (%)	2.5		X Walk 2 Slope (%)	N/A
	X Walk 1 X Slope (%)	4.5		X Walk 2 X Slope (%)	N/A

N/A	Ramp inside XWalk1?	N/A	N/A	Ramp inside XWalk2?	N/A
	Road Slope (%)	4.5		Clear Space?	N/A
	Road X Slope (%)	2.5	N/A	Clear Space to XWalk (in)	N/A
N/A	Any Obstructions?	N/A	N/A	Storm Grate/Utility Hazard?	N/A
	Obstruction Type			Storm Grate/Utility Type	
		N/A			N/A
			Yes	Surface Condition? (G/P)	Good
			No	Curb Slope (%)	5.2

Remove & Replace Curb Ramp With Two New Directional Ramps or Equivalent.

Total Cost: \$ 3200.00
