# Access Compliance Report

## Public Rights-of-Way (Curb Ramps)

Intersection ID: 45491	Main Street: GRASSY_CROPS_RD	Cross Street: TRIANGLE_PARK_RD	Location:	N
ADA ID: B17E7095FD1B	Ramp Type: Perp	Initial Pass/Fail: Fail	Overall Compliance: No	Severity Score: 12.5

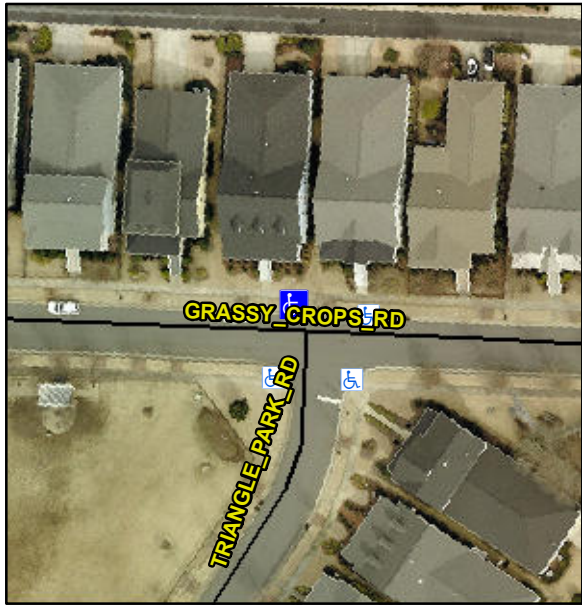
Possible Solutions:		Compliance	Description	Data	Compliance	Description	Data
	Remove & Replace Entire Ramp.		N/A	Ramp Length (in)	71.0	No	Ramp Slope (%)	10.0
			Yes	Ramp Width (in)	48.0	Yes	Ramp XSlope (%)	0.4
			N/A	Flare Type LT	N/A	N/A	Flare Type RT	N/A
			N/A	Flare Slope LT (%)	N/A	N/A	Flare Slope RT (%)	N/A
			N/A	Flare Traversable LT?	N/A	N/A	Flare Traversable RT?	N/A
			N/A	Landing Length (in)	N/A	N/A	DWS Provided?	N/A
			N/A	Landing Width (in)	N/A	N/A	DWS Contrast?	N/A
			N/A	Landing Slope (%)	N/A	N/A	DWS Length (in)	N/A
			N/A	Landing X Slope (%)	N/A	N/A	DWS Full Width?	N/A
Surveyor Notes:	N/A		N/A	Landing Curb? (Y/N)	N/A	N/A	DWS Offset (in)	N/A
			N/A	Shared Landing?	N/A			
	PROW/ADA:		N/A	Gutter Ponding?	N/A	N/A	Gutter Slope (%)	N/A
	Not Found, R304.2.2		N/A	Gutter Lip Ht (in)	N/A	N/A	Gutter X Slope (%)	N/A

N/A	Painted X Walk1?	No	N/A	Painted X Walk2?	N/A
				X Walk 1 Direction	To SW		X Walk 2 Direction	N/A
			N/A	X Walk 1 Width (in)	N/A	N/A	X Walk 2 Width (in)	N/A
				X Walk 1 Slope (%)	2.9		X Walk 2 Slope (%)	N/A
				X Walk 1 X Slope (%)	0.4		X Walk 2 X Slope (%)	N/A
			N/A	Ramp inside XWalk1?	N/A	N/A	Ramp inside XWalk2?	N/A
			Road Slope (%)	N/A	N/A	Clear Space?	N/A	
			Road X Slope (%)	N/A	N/A	Clear Space to XWalk (in)	N/A	
		N/A	Any Obstructions?	N/A	N/A	Storm Grate/Utility Hazard?	N/A	
			Obstruction Type			Storm Grate/Utility Type		
					N/A			N/A
						Yes	Surface Condition? (G/P)	Good
Street 1 Name			GRASSY CROPS RD					
Stop Condition-Street 2			None					
Street 2 Name			N/A					
Stop Condition-Street 1			N/A					
Total Cost:			\$	1850.00
