Access Compliance Report

Public Rights-of-Way

(Curb Ramps)

Intersection ID: 2591	Main Street: BEARDSLEY_DR	Cross Street: HARTFIELD_DOWNS_DR	Location: SE
ADA ID: B198030C0FC6	Ramp Type: Perp	Initial Pass/Fail: Fail	Overall Compliance: No
Codes/Mitigation Info/Possible Solution			Severity Score: 35
			Field Measurements/Component Compliance

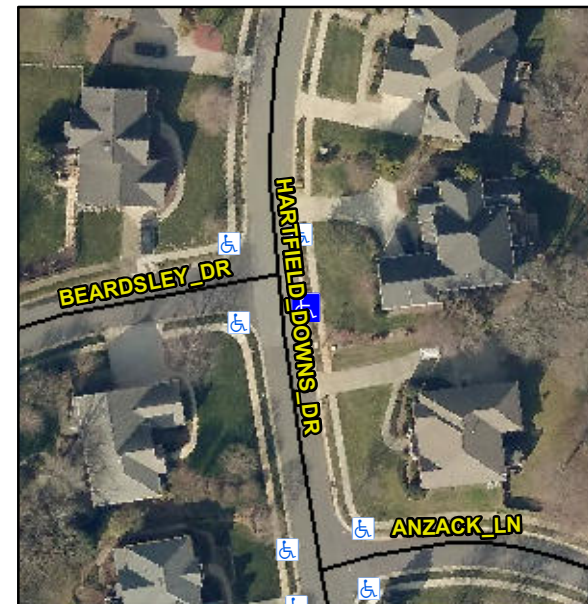
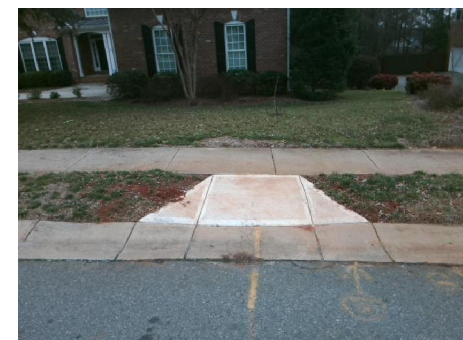
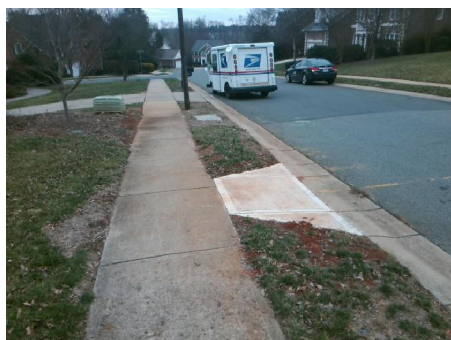
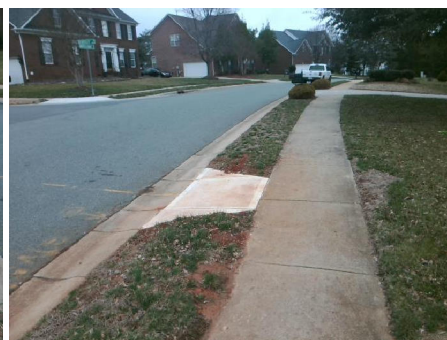
Not Found, R304.5.1, R304.2.2

Compliance	Description	Data	Compliance	Description	Data
N/A	Ramp Length (in)	48.0	No	Ramp Slope (%)	12.6
No	Ramp Width (in)	46.0	Yes	Ramp XSlope (%)	2.4
N/A	Flare Type LT	N/A	N/A	Flare Type RT	N/A
N/A	Flare Slope LT (%)	N/A	N/A	Flare Slope RT (%)	N/A
N/A	Flare Traversable LT?	N/A	N/A	Flare Traversable RT?	N/A
N/A	Landing Length (in)	N/A	N/A	DWS Provided?	N/A
N/A	Landing Width (in)	N/A	N/A	DWS Contrast?	N/A
N/A	Landing Slope (%)	N/A	N/A	DWS Length (in)	N/A
N/A	Landing X Slope (%)	N/A	N/A	DWS Full Width?	N/A
N/A	Landing Curb? (Y/N)	N/A	N/A	DWS Offset (in)	N/A
N/A	Shared Landing?	N/A			
N/A	Gutter Ponding?	N/A	N/A	Gutter Slope (%)	N/A
N/A	Gutter Lip Ht (in)	N/A	N/A	Gutter X Slope (%)	N/A
N/A	Painted X Walk1?	No	N/A	Painted X Walk2?	N/A
	X Walk 1 Direction	To W		X Walk 2 Direction	N/A
N/A	X Walk 1 Width (in)	N/A	N/A	X Walk 2 Width (in)	N/A
	X Walk 1 Slope (%)	3.2		X Walk 2 Slope (%)	N/A
	X Walk 1 X Slope (%)	4.2		X Walk 2 X Slope (%)	N/A

N/A	Ramp inside XWalk1?	N/A	N/A	Ramp inside XWalk2?	N/A
	Road Slope (%)	N/A	N/A	Clear Space?	N/A
	Road X Slope (%)	N/A	N/A	Clear Space to XWalk (in)	N/A
N/A	Any Obstructions?	N/A	N/A	Storm Grate/Utility Hazard?	N/A
	Obstruction Type			Storm Grate/Utility Type	
		N/A			N/A
			Yes	Surface Condition? (G/P)	Good

Remove & Replace Entire Ramp.
