# Access Compliance Report

## Public Rights-of-Way

### (Curb Ramps)

| Intersection ID: 10193 | Main Street: N_GRAHAM_ST | Cross Street: WOLFBERRY_ST | Location: S |

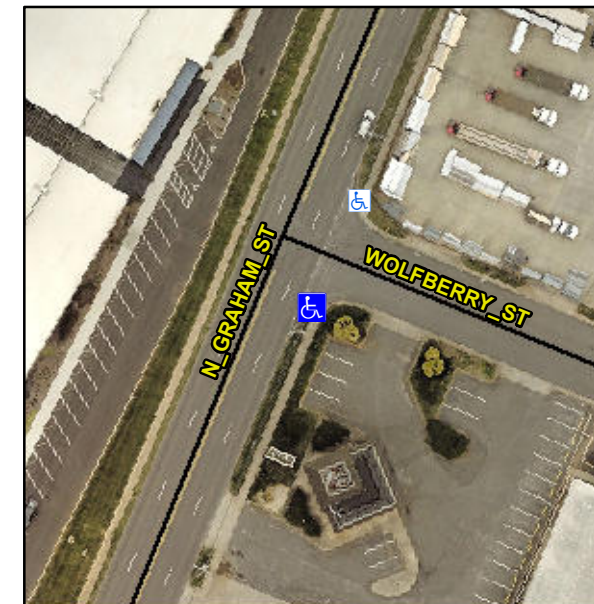
| ADA ID: B1B1C88037ED | Ramp Type: Perp | Initial Pass/Fail: Fail | Overall Compliance: No |
| | | Severity Score: 12.5 | |

**Not Found, R304.2.2**

| Compliance | Description | Data | Compliance | Description | Data |
|---|---|---|---|---|---|
| N/A | Ramp Length (in) | 75.0 | No | Ramp Slope (%) | 10.5 |

**Remove & Replace Entire Ramp.**

Total Cost: \$ 1850.00
