# Access Compliance Report

## Public Rights-of-Way

### (Curb Ramps)

Intersection ID: 43710	Main Street: OLDE_ENGLISH_DR	Cross Street: PHEASANT_CHASE_LN	Location: NW
ADA ID: B1B87C9F9A9E	Ramp Type: PerpDiag	Initial Pass/Fail: Fail	Overall Compliance: No
		Severity Score: 33.75

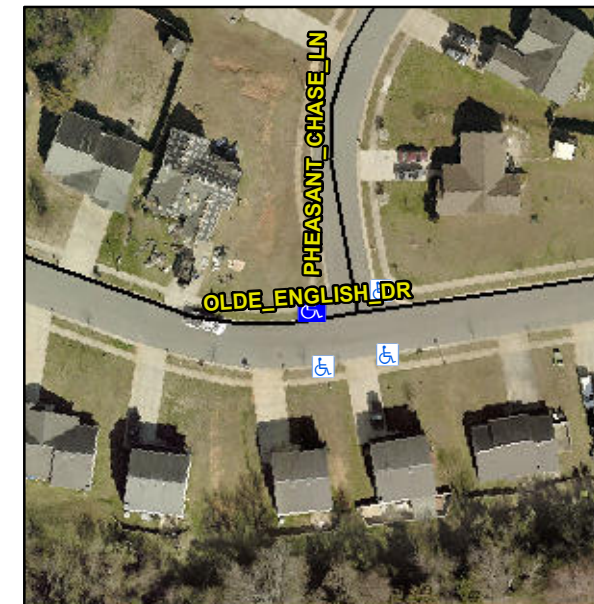
**Not Found, R304.5.1, R304.5.3**

Compliance	Description	Data	Compliance	Description	Data
N/A	Ramp Length (in)	47.0	Yes	Ramp Slope (%)	7.6
No	Ramp Width (in)	47.5	No	Ramp XSlope (%)	8.1
N/A	Flare Type LT	N/A	N/A	Flare Type RT	N/A
N/A	Flare Slope LT (%)	N/A	N/A	Flare Slope RT (%)	N/A
N/A	Flare Traversable LT?	N/A	N/A	Flare Traversable RT?	N/A
N/A	Landing Length (in)	N/A	N/A	DWS Provided?	N/A
N/A	Landing Width (in)	N/A	N/A	DWS Contrast?	N/A
N/A	Landing Slope (%)	N/A	N/A	DWS Length (in)	N/A
N/A	Landing X Slope (%)	N/A	N/A	DWS Full Width?	N/A
N/A	Landing Curb? (Y/N)	N/A	N/A	DWS Offset (in)	N/A
N/A	Shared Landing?	N/A			
N/A	Gutter Ponding?	N/A	N/A	Gutter Slope (%)	N/A
N/A	Gutter Lip Ht (in)	N/A	N/A	Gutter X Slope (%)	N/A
N/A	Painted X Walk1?	No	N/A	Painted X Walk2?	No
	X Walk 1 Direction	To S		X Walk 2 Direction	To E
N/A	X Walk 1 Width (in)	N/A	N/A	X Walk 2 Width (in)	N/A
	X Walk 1 Slope (%)	3.0		X Walk 2 Slope (%)	4.0
	X Walk 1 X Slope (%)	4.9		X Walk 2 X Slope (%)	3.4

N/A	Ramp inside XWalk1?	N/A	N/A	Ramp inside XWalk2?	N/A
	Road Slope (%)	6.0	N/A	Clear Space?	N/A
	Road X Slope (%)	4.4	N/A	Clear Space to XWalk (in)	N/A
N/A	Any Obstructions?	N/A	N/A	Storm Grate/Utility Hazard?	N/A
	Obstruction Type			Storm Grate/Utility Type	
		N/A			N/A
			Yes	Surface Condition? (G/P)	Good

**Remove & Replace Curb Ramp With Two New Directional Ramps or Equivalent.**

Total Cost: \$ 3200.00
