# Access Compliance Report

## Public Rights-of-Way

### (Curb Ramps)

| Intersection ID: 3954 | Main Street: MOUNTAIN_COVE_DR | Cross Street: OVERLOOK_COVE_RD | Location: NW |

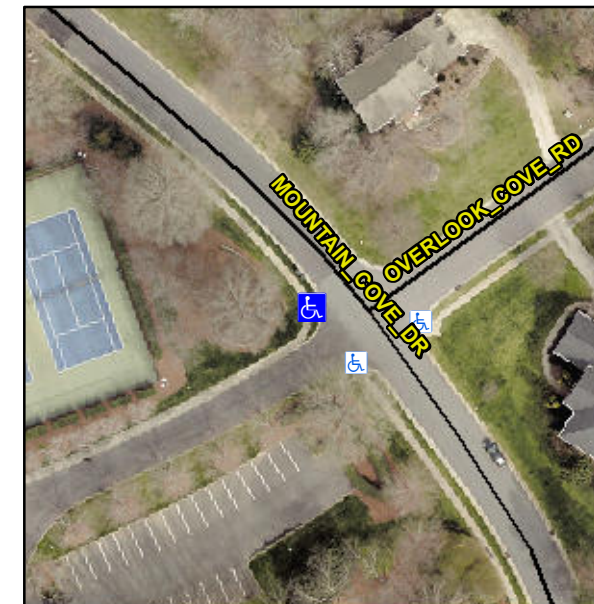
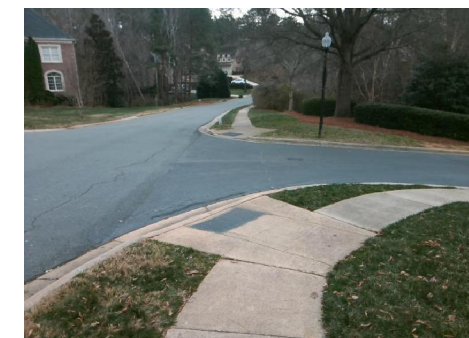
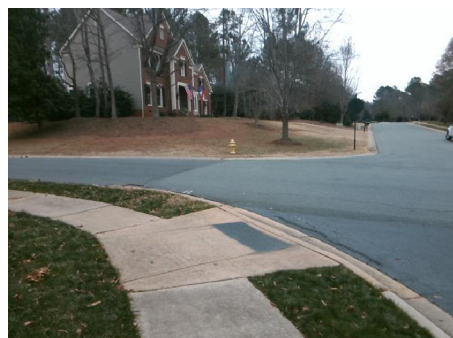
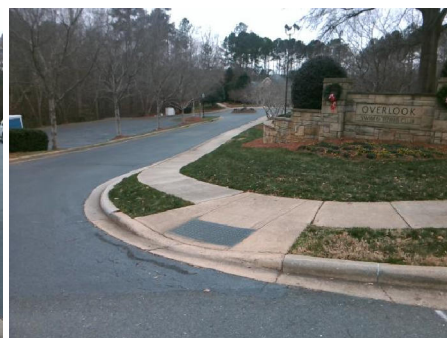
**Not Found, R304.5.1, R304.5.3**

| Compliance | Description | Data | Compliance | Description | Data |
|---|---|---|---|---|---|
| No | Ramp Width (in) | 46.5 | No | Ramp XSlope (%) | 13.4 |

**Remove & Replace Entire Ramp.**
