# Access Compliance Report

## Public Rights-of-Way

### (Curb Ramps)

| Intersection ID: 11231 | Main Street: W_4TH_ST_EXT | Cross Street: WALNUT_AV | Location: S |

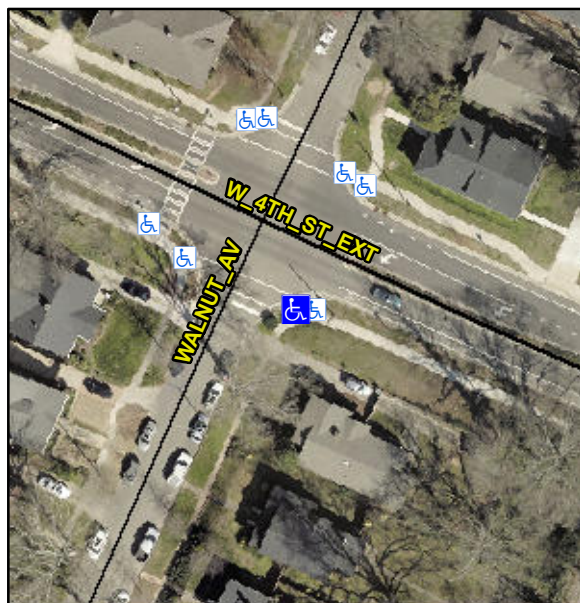
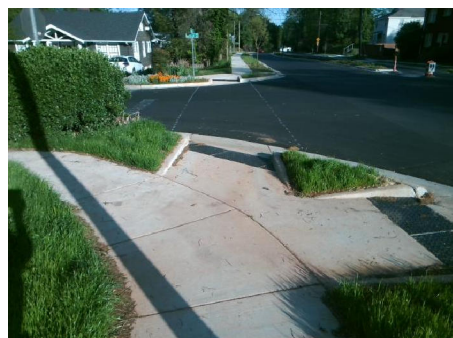
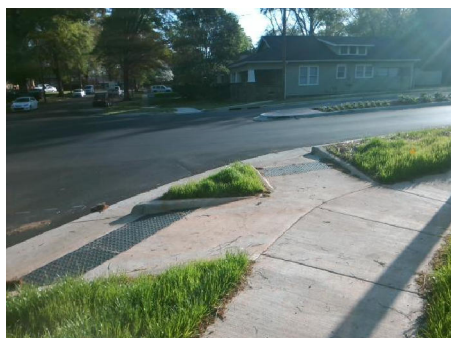
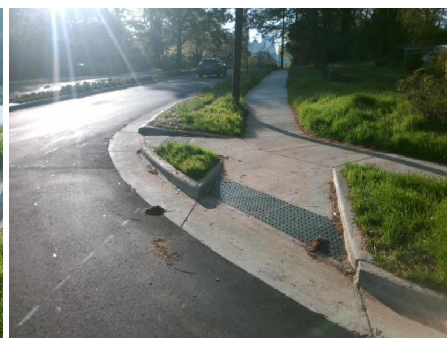
**Not Found, R304.5.3**

| Compliance | Description | Data | Compliance | Description | Data |
|---|---|---|---|---|---|
| Yes | Gutter Lip Ht (in) | 0.0 | No | Gutter X Slope (%) | 4.5 |

Possible Solutions:

**Remove & Replace Entire Ramp.  
Remove & Replace Gutter.**
