# Access Compliance Report

## Public Rights-of-Way

### (Curb Ramps)

Intersection ID: 9695	Main Street: FARRIOR_DR	Cross Street: THE_PLAZA	Location: NW
ADA ID: B1C722067620	Ramp Type: Perp	Initial Pass/Fail: Fail	Overall Compliance: No
Severity Score: 12.5			
Codes/Mitigation Info/Possible Solution		Field Measurements/Component Compliance

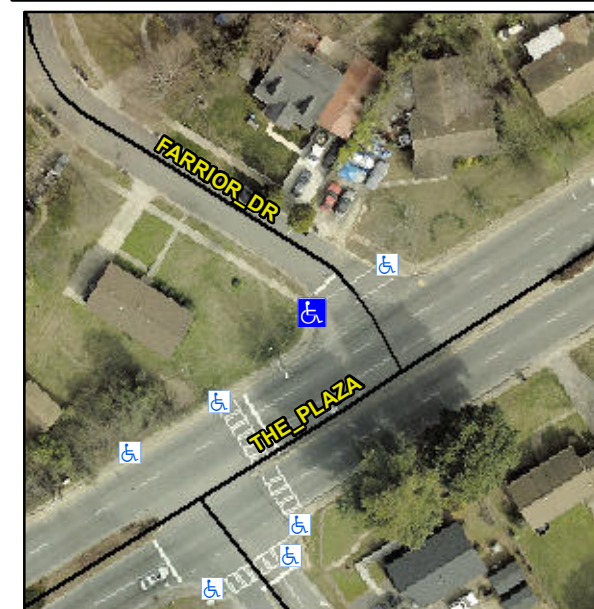
Compliance	Description	Data	Compliance	Description	Data
N/A	Ramp Length (in)	52.0	No	Ramp Slope (%)	11.0
Yes	Ramp Width (in)	48.0	Yes	Ramp XSlope (%)	1.7
N/A	Flare Type LT	N/A	N/A	Flare Type RT	N/A
N/A	Flare Slope LT (%)	N/A	N/A	Flare Slope RT (%)	N/A
N/A	Flare Traversable LT?	N/A	N/A	Flare Traversable RT?	N/A
N/A	Landing Length (in)	N/A	N/A	DWS Provided?	N/A
N/A	Landing Width (in)	N/A	N/A	DWS Contrast?	N/A
N/A	Landing Slope (%)	N/A	N/A	DWS Length (in)	N/A
N/A	Landing X Slope (%)	N/A	N/A	DWS Full Width?	N/A
N/A	Landing Curb? (Y/N)	N/A	N/A	DWS Offset (in)	N/A
N/A	Shared Landing?	N/A			
N/A	Gutter Ponding?	Yes	N/A	Gutter Slope (%)	N/A
N/A	Gutter Lip Ht (in)	N/A	N/A	Gutter X Slope (%)	N/A
N/A	Painted X Walk1?	No	N/A	Painted X Walk2?	N/A
	X Walk 1 Direction	To NE		X Walk 2 Direction	N/A
N/A	X Walk 1 Width (in)	N/A	N/A	X Walk 2 Width (in)	N/A
	X Walk 1 Slope (%)	2.1		X Walk 2 Slope (%)	N/A
	X Walk 1 X Slope (%)	3.1		X Walk 2 X Slope (%)	N/A

N/A	Ramp inside XWalk1?	N/A	N/A	Ramp inside XWalk2?	N/A
	Road Slope (%)	N/A	N/A	Clear Space?	N/A
	Road X Slope (%)	N/A	N/A	Clear Space to XWalk (in)	N/A
N/A	Any Obstructions?	N/A	N/A	Storm Grate/Utility Hazard?	N/A
	Obstruction Type			Storm Grate/Utility Type	
		N/A			N/A
		Yes		Surface Condition? (G/P)	Good

Possible Solutions:

**Remove & Replace Entire Ramp.**

**Not Found, R304.2.2**

Total Cost: \$ 1850.00
