Access Compliance Report

Public Rights-of-Way

(Curb Ramps)

Intersection ID: 52613	Main Street: GRAHAM RIDGE DR	Cross Street: HERITAGE POND DR	Location: S
ADA ID: B1CC399FE967	Ramp Type: Perp	Initial Pass/Fail: Pass	Overall Compliance: No
Severity Score: 5.25			
Codes/Mitigation Info/Possible Solution		Field Measurements/Component Compliance

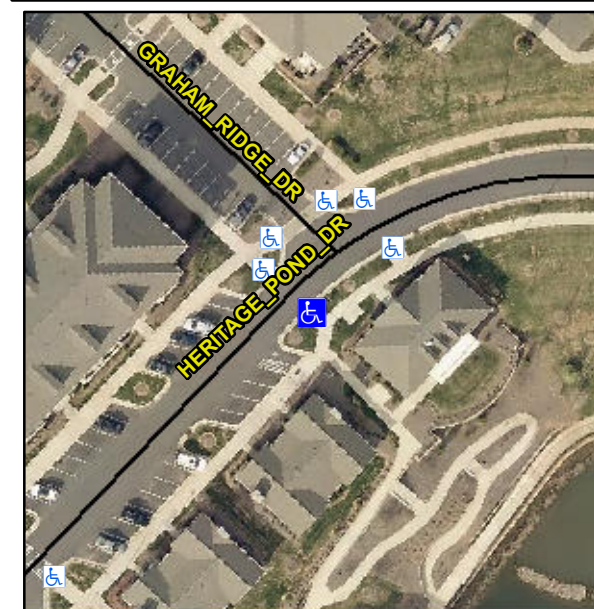
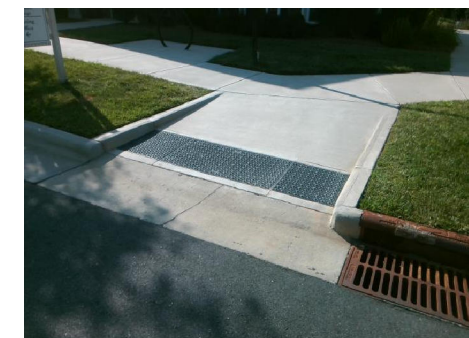
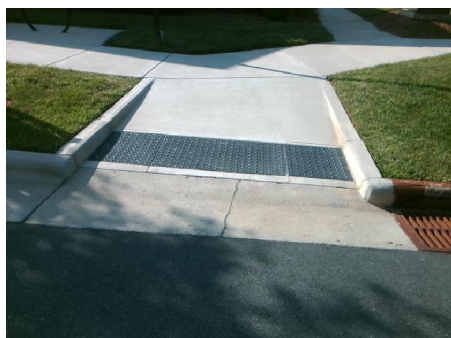
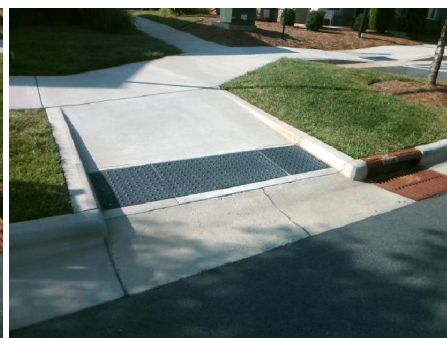
Compliance	Description	Data	Compliance	Description	Data
N/A	Ramp Length (in)	97.5	Yes	Ramp Slope (%)	7.1
Yes	Ramp Width (in)	92.5	No	Ramp XSlope (%)	2.1
Yes	Flare Type L	Curbed_NoWalkSurface	Yes	Flare Type RT	N/A
Yes	Flare Slope LT (%)	N/A	N/A	Flare Slope RT (%)	N/A
N/A	Flare Traversable LT?	No	N/A	Flare Traversable RT?	No
Yes	Landing Length (in)	68.0	Yes	DWS Provided?	Yes
Yes	Landing Width (in)	109.0	Yes	DWS Contrast?	Yes
Yes	Landing Slope (%)	1.5	Yes	DWS Length (in)	24.0
Yes	Landing X Slope (%)	0.4	Yes	DWS Full Width?	Yes
N/A	Landing Curb? (Y/N)	No	No	DWS Offset (in)	4.0
N/A	Shared Landing?	No			
Yes	Gutter Ponding?	No	No	Gutter Slope (%)	5.3
Yes	Gutter Lip Ht (in)	0.0	Yes	Gutter X Slope (%)	1.1
N/A	Painted X Walk1?	No	N/A	Painted X Walk2?	N/A
	X Walk 1 Direction	To NW		X Walk 2 Direction	N/A
N/A	X Walk 1 Width (in)	N/A	N/A	X Walk 2 Width (in)	N/A
	X Walk 1 Slope (%)	4.0		X Walk 2 Slope (%)	N/A
	X Walk 1 X Slope (%)	1.3		X Walk 2 X Slope (%)	N/A

N/A	Ramp inside XWalk1?	N/A	N/A	Ramp inside XWalk2?	N/A
	Road Slope (%)	N/A	N/A	Clear Space?	Yes
	Road X Slope (%)	N/A	N/A	Clear Space to XWalk (in)	N/A
Yes	Any Obstructions?	No	Yes	Storm Grate/Utility Hazard?	No
	Obstruction Type			Storm Grate/Utility Type	
		N/A			N/A
			Yes	Surface Condition? (G/P)	Good

Possible Solutions:

**Remove & Replace Entire Ramp.
Remove & Replace Gutter.**

R304.5.3, R305.2, R304.5.4
