# Access Compliance Report

## Public Rights-of-Way

### (Curb Ramps)

Intersection ID: 13925	Main Street: BERKELEY_AV	Cross Street: EUCLID_AV	Location: S
ADA ID: B1CD36F94083	Ramp Type: PerpDiag	Initial Pass/Fail: Fail	Overall Compliance: No
Severity Score: 26.25			
Codes/Mitigation Info/Possible Solution		Field Measurements/Component Compliance

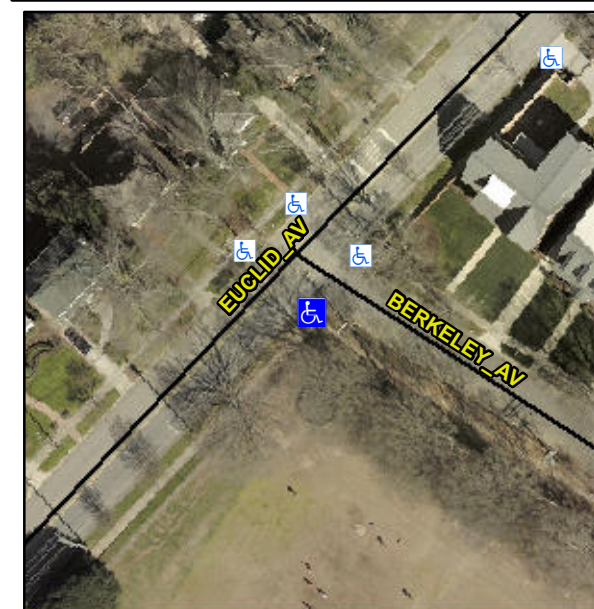
**Not Found, R304.2.2, R304.5.3**

Compliance	Description	Data	Compliance	Description	Data
N/A	Ramp Length (in)	72.0	No	Ramp Slope (%)	14.8
Yes	Ramp Width (in)	48.0	No	Ramp XSlope (%)	4.8
N/A	Flare Type LT	N/A	N/A	Flare Type RT	N/A
N/A	Flare Slope LT (%)	N/A	N/A	Flare Slope RT (%)	N/A
N/A	Flare Traversable LT?	N/A	N/A	Flare Traversable RT?	N/A
N/A	Landing Length (in)	N/A	N/A	DWS Provided?	N/A
N/A	Landing Width (in)	N/A	N/A	DWS Contrast?	N/A
N/A	Landing Slope (%)	N/A	N/A	DWS Length (in)	N/A
N/A	Landing X Slope (%)	N/A	N/A	DWS Full Width?	N/A
N/A	Landing Curb? (Y/N)	N/A	N/A	DWS Offset (in)	N/A
N/A	Shared Landing?	N/A			
N/A	Gutter Ponding?	Yes	N/A	Gutter Slope (%)	N/A
N/A	Gutter Lip Ht (in)	N/A	N/A	Gutter X Slope (%)	N/A
N/A	Painted X Walk1?	No	N/A	Painted X Walk2?	No
	X Walk 1 Direction	To NE		X Walk 2 Direction	To NW
N/A	X Walk 1 Width (in)	N/A	N/A	X Walk 2 Width (in)	N/A
	X Walk 1 Slope (%)	1.2		X Walk 2 Slope (%)	7.9
	X Walk 1 X Slope (%)	4.8		X Walk 2 X Slope (%)	2.4

N/A	Ramp inside XWalk1?	N/A	N/A	Ramp inside XWalk2?	N/A
	Road Slope (%)	4.8	N/A	Clear Space?	N/A
	Road X Slope (%)	0.9	N/A	Clear Space to XWalk (in)	N/A
N/A	Any Obstructions?	N/A	N/A	Storm Grate/Utility Hazard?	N/A
	Obstruction Type			Storm Grate/Utility Type	
		N/A			N/A
		Yes		Surface Condition? (G/P)	Good

**Remove & Replace Curb Ramp With Two New Directional Ramps or Equivalent.**

Total Cost: \$ 3200.00
