# Access Compliance Report

## Public Rights-of-Way

### (Curb Ramps)

| Intersection ID: 2527 | Main Street: CAMBRIDGE_BAY_DR | Cross Street: LAGRANDE_DR | Location: SE |

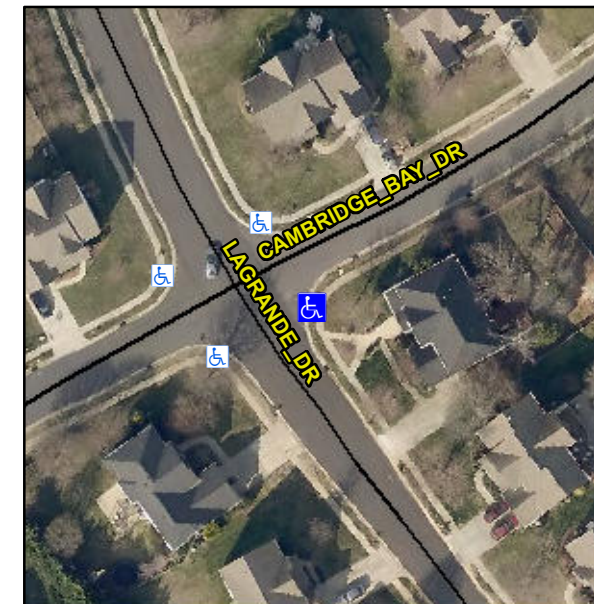
**R304.5.3, R304.2.2-Perp, R304.3.2-Para, R305.2, R302.7, R302.7.2**

| Compliance | Description | Data | Compliance | Description | Data |
|---|---|---|---|---|---|
| Yes | Ramp Width (in) | 48.0 | No | Ramp XSlope (%) | 2.3 |
| No | Landing Slope (%) | 4.4 | Yes | DWS Length (in) | 24.0 |
| N/A | Landing Curb? (Y/N) | No | No | DWS Offset (in) | 3.0 |
| No | Gutter Ponding? | Yes | Yes | Gutter Slope (%) | 0.4 |
| No | Gutter Lip Ht (in) | 0.5 | Yes | Gutter X Slope (%) | 1.6 |

**Remove & Replace Curb Ramp With Two New Directional Ramps or Equivalent. Grind Gutter Lip.**
