Access Compliance Report

Public Rights-of-Way

(Curb Ramps)

Intersection ID: 11246	Main Street: ALLEN_ST	Cross Street: CATAWBA_AV	Location: SE
ADA ID: B1D779A6AA4B	Ramp Type: PerpDiag	Initial Pass/Fail: Fail	Overall Compliance: No
		Severity Score: 50

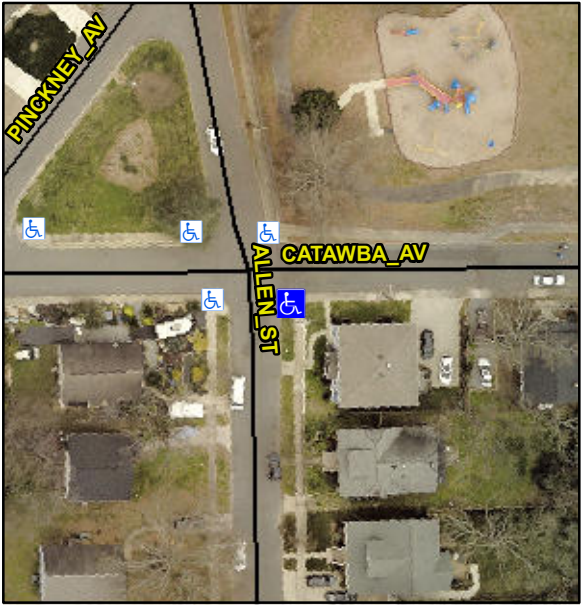
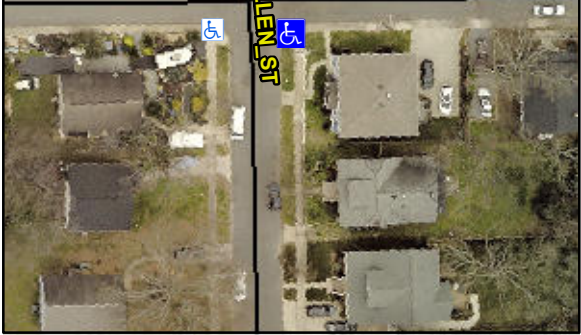
Surveyor Notes:		No	Ramp Length (in)	36.0
	N/A		No	Ramp Width (in)	62.0

Possible Solutions:		Compliance	Description	Data
	Remove & Replace Curb Ramp With Two New Directional Ramps or Equivalent.		Compliance	Description	Data

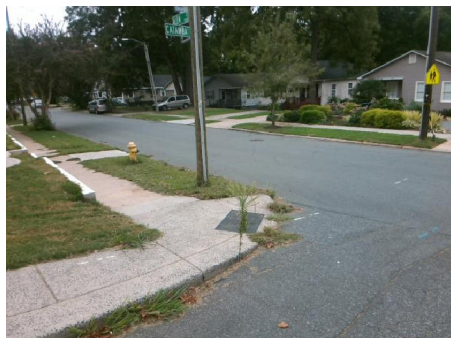
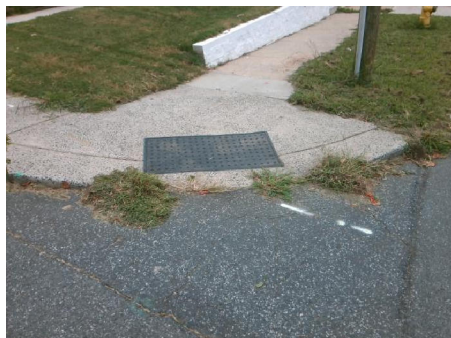
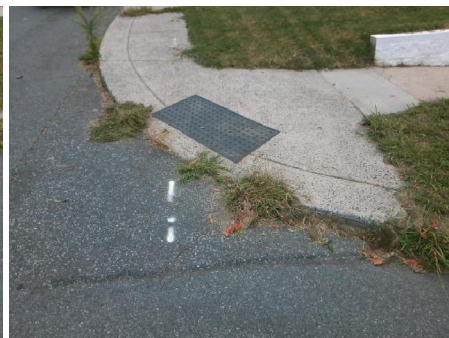
11.1	X Walk 2 Slope (%)	1.7
			5.3	X Walk 2 X Slope (%)	5.3

Total Cost: \$ 3200.00
