Access Compliance Report

Public Rights-of-Way

(Curb Ramps)

Intersection ID: 52476	Main Street: WHITEHALL_EXECUTIVE_CENTER_DR	Cross Street: CERNAL_DR	Location: SE
ADA ID: B1DD87EC4E7B	Ramp Type: Perp	Initial Pass/Fail: Fail	Overall Compliance: No
Severity Score: 12.5			
Codes/Mitigation Info/Possible Solution		Field Measurements/Component Compliance

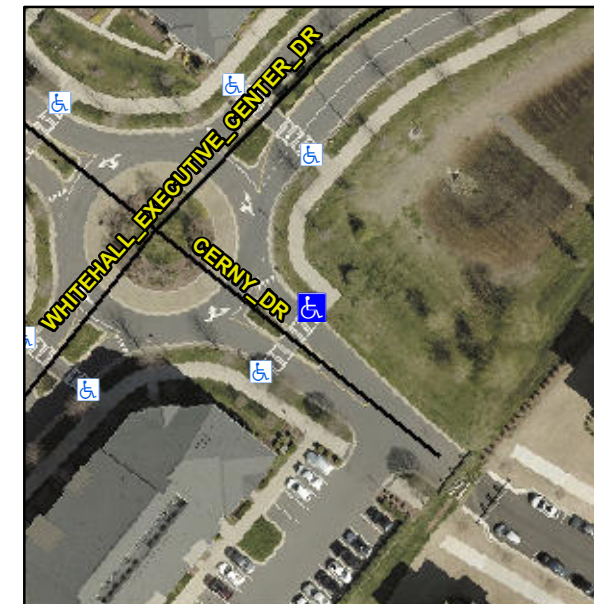
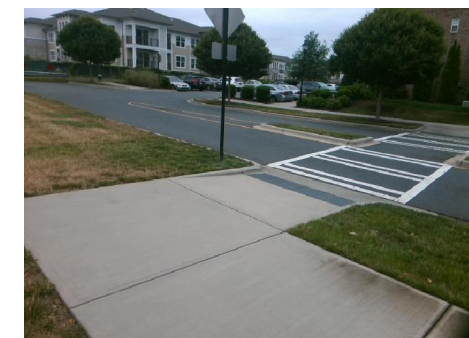
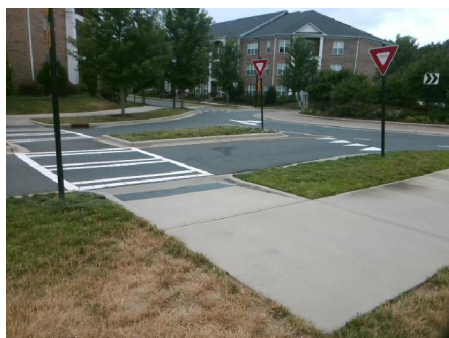
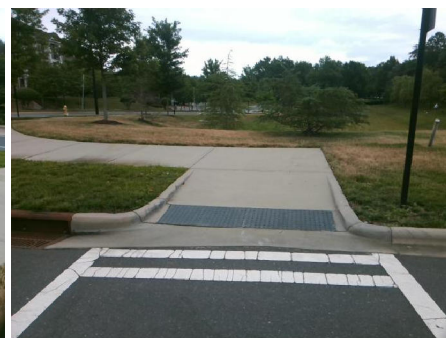
Compliance	Description	Data	Compliance	Description	Data
N/A	Ramp Length (in)	94.0	No	Ramp Slope (%)	8.7
Yes	Ramp Width (in)	97.0	Yes	Ramp XSlope (%)	1.4
N/A	Flare Type LT	N/A	N/A	Flare Type RT	N/A
N/A	Flare Slope LT (%)	N/A	N/A	Flare Slope RT (%)	N/A
N/A	Flare Traversable LT?	N/A	N/A	Flare Traversable RT?	N/A
N/A	Landing Length (in)	N/A	N/A	DWS Provided?	N/A
N/A	Landing Width (in)	N/A	N/A	DWS Contrast?	N/A
N/A	Landing Slope (%)	N/A	N/A	DWS Length (in)	N/A
N/A	Landing X Slope (%)	N/A	N/A	DWS Full Width?	N/A
N/A	Landing Curb? (Y/N)	N/A	N/A	DWS Offset (in)	N/A
N/A	Shared Landing?	N/A			
N/A	Gutter Ponding?	N/A	N/A	Gutter Slope (%)	N/A
N/A	Gutter Lip Ht (in)	N/A	N/A	Gutter X Slope (%)	N/A
N/A	Painted X Walk1?	Yes	N/A	Painted X Walk2?	N/A
	X Walk 1 Direction	To SW		X Walk 2 Direction	N/A
N/A	X Walk 1 Width (in)	112.0	N/A	X Walk 2 Width (in)	N/A
	X Walk 1 Slope (%)	1.7		X Walk 2 Slope (%)	N/A
	X Walk 1 X Slope (%)	2.0		X Walk 2 X Slope (%)	N/A

N/A	Ramp inside XWalk1?	Yes	N/A	Ramp inside XWalk2?	N/A
	Road Slope (%)	N/A	N/A	Clear Space?	N/A
	Road X Slope (%)	N/A	N/A	Clear Space to XWalk (in)	N/A
N/A	Any Obstructions?	N/A	N/A	Storm Grate/Utility Hazard?	N/A
	Obstruction Type			Storm Grate/Utility Type	
		N/A			N/A
		Yes		Surface Condition? (G/P)	Good

Remove & Replace Entire Ramp.
