## **Access Compliance Report Public Rights-of-Way** (Curb Ramps)

Intersection ID: 11867 Main Street: E\_17TH\_ST **Cross Street: SEIGLE AV** Location: SE **Overall Compliance: No ADA ID: B1E642ECA513** Ramp Type: BlendTrans1 Initial Pass/Fail: Fail **Severity Score:** 25

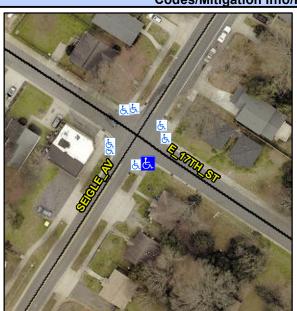
Comp	liance Description	Data	Comp	liance	Description	Data
N/A	Ramp Length (in)	70.0	Yes	Blend	Γrans Slope (%)	2.6
Yes	Ramp Width (in)	77.0	No	Blend	Γrans XSlope (%)	7.1
N/A	Flare Type LT	N/A	N/A	Flare <sup>-</sup>	Гуре RT	N/A
N/A	Flare Slope LT (%)	N/A	N/A	Flare	Slope RT (%)	N/A
N/A	Flare Traversable LT?	N/A	N/A	Flare <sup>-</sup>	Traversable RT?	N/A
N/A	Landing Length (in)	N/A	N/A	DWS	Provided?	N/A
N/A	Landing Width (in)	N/A	N/A	DWS	Contrast?	N/A
N/A	Landing Slope (%)	N/A	N/A	DWS	Length (in)	N/A
N/A	Landing X Slope (%)	N/A	N/A	DWS	Full Width?	N/A
N/A	Landing Curb? (Y/N)	N/A	N/A	DWS	Offset (in)	N/A
N/A	Shared Landing?	N/A				
N/A	Gutter Ponding?	N/A	N/A	Gutter	Slope (%)	N/A
N/A	Gutter Lip Ht (in)	N/A	N/A	Gutter	X Slope (%)	N/A
N/A	Painted X Walk1?	No	N/A	Painte	d X Walk2?	N/A
	X Walk 1 Direction	To NE		X Wall	k 2 Direction	N/A
	X Walk 1 Width (in)	N/A		X Wall	k 2 Width (in)	N/A
	X Walk 1 Slope (%)	4.1		X Wall	k 2 Slope (%)	N/A

X Walk 1 X Slope (%)	3.6		X Wall	k 2 X Slope (%)	N/A
N/A	Ramp inside XWalk1?	N/A	N/A	Ramp	inside XWalk2?	N/A
	Road Slope (%)	3.6		Clear	Space?	N/A
	Road X Slope (%)	4.1	N/A	Clear	Space to XWalk (in)	N/A
N/A	Any Obstructions?	N/A	N/A	Storm	Grate/Utility Hazard?	N/A
	Obstruction Type			Storm	Grate/Utility Type

Street 1 Name Stop Condition-Street 1 Street 2 Name Stop Condition-Street 2 Possible Solutions: Remove & Replace Curb Ramp With **Two New Directional Ramps or** Equivalent. Surveyor Notes:

PROW/ADA: R304.5.3
