Access Compliance Report

Public Rights-of-Way

(Curb Ramps)

Intersection ID: 28345	Main Street: BACARDI_CT	Cross Street: HIRSCH_DR	Location: SE
ADA ID: B1EFAE09CD53	Ramp Type: Perp	Initial Pass/Fail: Fail	Overall Compliance: No
		Severity Score: 30

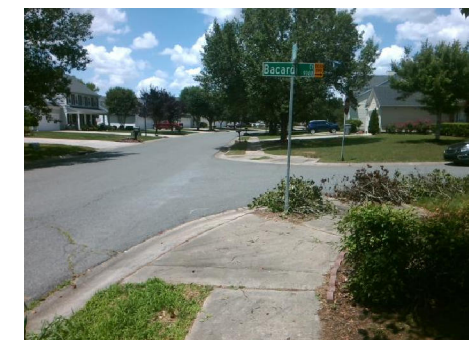
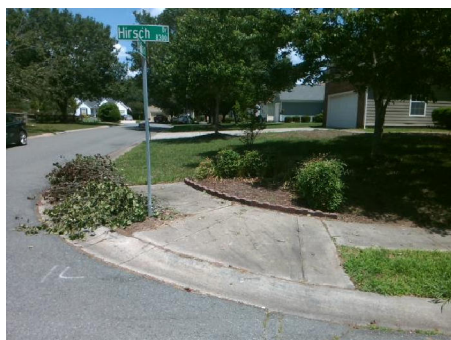
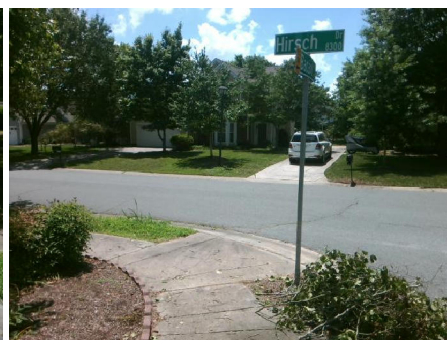
Not Found, R304.5.1, R304.5.3

Compliance	Description	Data	Compliance	Description	Data
N/A	Ramp Length (in)	93.0	Yes	Ramp Slope (%)	6.6
No	Ramp Width (in)	32.0	No	Ramp XSlope (%)	6.9
N/A	Flare Type LT	N/A	N/A	Flare Type RT	N/A
N/A	Flare Slope LT (%)	N/A	N/A	Flare Slope RT (%)	N/A
N/A	Flare Traversable LT?	N/A	N/A	Flare Traversable RT?	N/A
N/A	Landing Length (in)	N/A	N/A	DWS Provided?	N/A
N/A	Landing Width (in)	N/A	N/A	DWS Contrast?	N/A
N/A	Landing Slope (%)	N/A	N/A	DWS Length (in)	N/A
N/A	Landing X Slope (%)	N/A	N/A	DWS Full Width?	N/A
N/A	Landing Curb? (Y/N)	N/A	N/A	DWS Offset (in)	N/A
N/A	Shared Landing?	N/A			
N/A	Gutter Ponding?	N/A	N/A	Gutter Slope (%)	N/A
N/A	Gutter Lip Ht (in)	N/A	N/A	Gutter X Slope (%)	N/A
N/A	Painted X Walk1?	No	N/A	Painted X Walk2?	N/A
	X Walk 1 Direction	To SW		X Walk 2 Direction	N/A
N/A	X Walk 1 Width (in)	N/A	N/A	X Walk 2 Width (in)	N/A
	X Walk 1 Slope (%)	1.3		X Walk 2 Slope (%)	N/A
	X Walk 1 X Slope (%)	3.3		X Walk 2 X Slope (%)	N/A

N/A	Ramp inside XWalk1?	N/A	N/A	Ramp inside XWalk2?	N/A
	Road Slope (%)	N/A	N/A	Clear Space?	N/A
	Road X Slope (%)	N/A	N/A	Clear Space to XWalk (in)	N/A
N/A	Any Obstructions?	N/A	N/A	Storm Grate/Utility Hazard?	N/A
	Obstruction Type			Storm Grate/Utility Type	
		N/A			N/A
			Yes	Surface Condition? (G/P)	Good

Remove & Replace Entire Ramp.
