Access Compliance Report

Public Rights-of-Way

(Curb Ramps)

Intersection ID: 28491	Main Street: S_TRYON_ST	Cross Street: TYVOLA_CENTRE_DR	Location: SE
ADA ID: B1F1C2EABDF6	Ramp Type: PerpDiag	Initial Pass/Fail: Pass	Overall Compliance: No
		Severity Score: 0

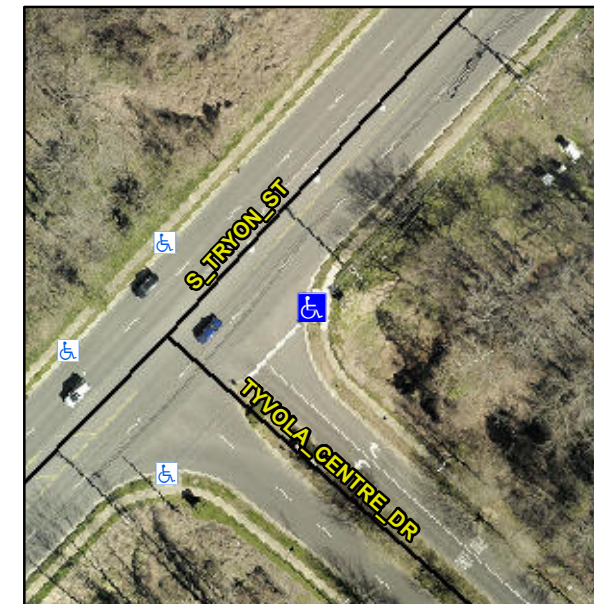
Compliance	Description	Data	Compliance	Description	Data
N/A	Ramp Length (in)	72.0	Yes	Ramp Slope (%)	7.2
Yes	Ramp Width (in)	60.0	Yes	Ramp XSlope (%)	1.4
N/A	Flare Type LT	Sloped	N/A	Flare Type RT	N/A
N/A	Flare Slope LT (%)	4.5	N/A	Flare Slope RT (%)	3.2
N/A	Flare Traversable LT?	No	N/A	Flare Traversable RT?	No
Yes	Landing Length (in)	54.0	Yes	DWS Provided?	Yes
Yes	Landing Width (in)	60.0	Yes	DWS Contrast?	Yes
Yes	Landing Slope (%)	0.4	Yes	DWS Length (in)	24.0
Yes	Landing X Slope (%)	0.7	Yes	DWS Full Width?	Yes
N/A	Landing Curb? (Y/N)	No	Yes	DWS Offset (in)	1.0
N/A	Shared Landing?	No			
Yes	Gutter Ponding?	No	Yes	Gutter Slope (%)	1.7
Yes	Gutter Lip Ht (in)	0.0	Yes	Gutter X Slope (%)	1.2
N/A	Painted X Walk1?	No	N/A	Painted X Walk2?	No
	X Walk 1 Direction	To N		X Walk 2 Direction	To W
N/A	X Walk 1 Width (in)	N/A	N/A	X Walk 2 Width (in)	N/A
	X Walk 1 Slope (%)	2.5		X Walk 2 Slope (%)	1.5
	X Walk 1 X Slope (%)	0.7		X Walk 2 X Slope (%)	2.0

N/A	Ramp inside XWalk1?	N/A	N/A	Ramp inside XWalk2?	N/A
	Road Slope (%)	2.9	N/A	Clear Space?	Yes
	Road X Slope (%)	0.1	N/A	Clear Space to XWalk (in)	N/A
Yes	Any Obstructions?	No	Yes	Storm Grate/Utility Hazard?	No
	Obstruction Type			Storm Grate/Utility Type	
		N/A			N/A
			Yes	Surface Condition? (G/P)	Good

Possible Solutions:

Remove & Replace Curb Slope and Extend Ramp.
