# Access Compliance Report

## Public Rights-of-Way

### (Curb Ramps)

| Intersection ID: 49242 | Main Street: HUBBARD_RD | Cross Street: HUBBARD_POINT_DR | Location: SE |

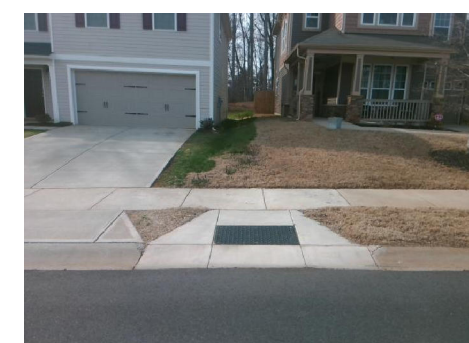
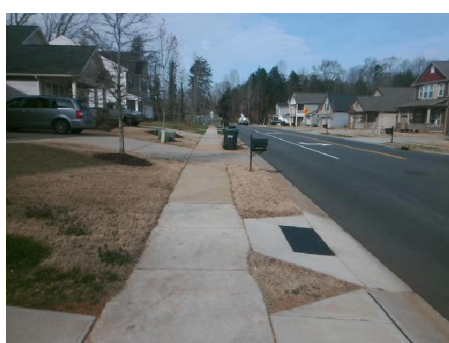
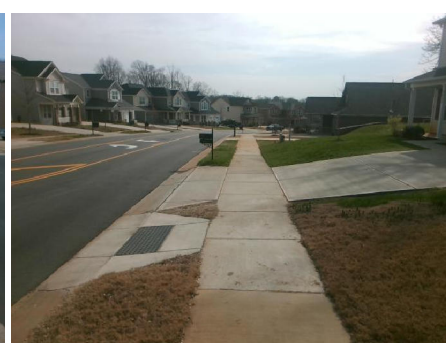
**Not Found, R304.2.2, R304.5.3**

| Compliance | Description | Data | Compliance | Description | Data |
|---|---|---|---|---|---|
| N/A | Ramp Length (in) | 48.0 | No | Ramp Slope (%) | 9.9 |
| Yes | Ramp Width (in) | 48.0 | No | Ramp XSlope (%) | 3.1 |

**Remove & Replace Entire Ramp.**
