Access Compliance Report

Public Rights-of-Way

(Curb Ramps)

Intersection ID: 21044	Main Street: PARK_SOUTH_DR	Cross Street: ROUND_OAK_RD	Location: SE
ADA ID: B1F58B4566C6	Ramp Type: Directional1	Initial Pass/Fail: Fail	Overall Compliance: No
Codes/Mitigation Info/Possible Solution		Field Measurements/Component Compliance

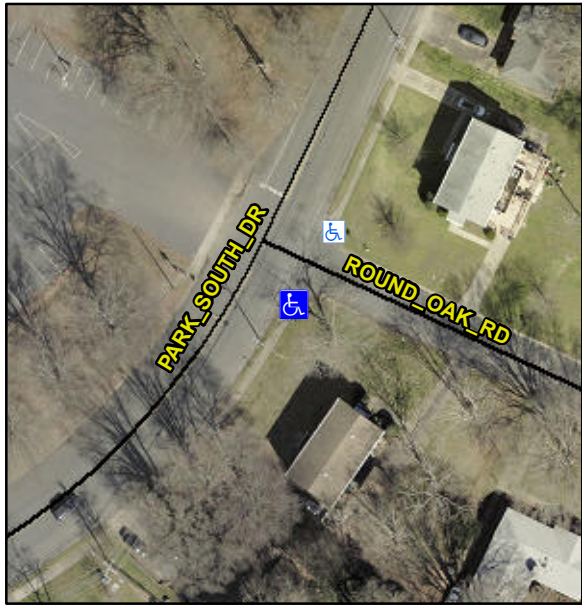
Compliance		Description	Data	Compliance		Description	Data
N/A	Ramp Length (in)	134.0	N/A	Grade Break?	N/A		
No	Ramp Width (in)	40.0	N/A	Grade Break Slope (%)	0.0		
No	Ramp Slope (%)	10.2	N/A	Grade Break XSlope (%)	0.0		
Yes	Ramp XSlope (%)	1.9					
N/A	Flare Type LT	N/A	N/A	Flare Type RT	N/A		
N/A	Flare Slope LT (%)	N/A	N/A	Flare Slope RT (%)	0.0		
N/A	Flare Traversable LT?	N/A	N/A	Flare Traversable RT?	N/A		
N/A	Landing Length (in)	0.0	N/A	DWS Provided?	N/A		
N/A	Landing Width (in)	0.0	N/A	DWS Contrast?	N/A		
N/A	Landing Slope (%)	0.0	N/A	DWS Length (in)	N/A		
N/A	Landing X Slope (%)	0.0	N/A	DWS Full Width?	N/A		
N/A	Landing Curb? (Y/N)	N/A	N/A	DWS Offset LT (in)	N/A		
N/A	Shared Landing?	N/A	N/A	DWS Offset RT (in)	N/A		
N/A	Gutter Ponding?	0.0	N/A	Gutter Slope (%)	N/A		
N/A	Gutter Lip Ht (in)	0.0	N/A	Gutter X Slope (%)	N/A		
N/A	Painted X Walk1?	No		Road Slope (%)	0.1		
	X Walk 1 Direction	To N		Road X Slope (%)	3.7

X Walk 1 Width (in)	N/A		Clear Space?	N/A		
	X Walk 1 Slope (%)	0.1	N/A	Clear Space to XWalk (in)	N/A		
	X Walk 1 X Slope (%)	3.7	N/A	Storm Grate/Utility Hazard?	N/A		
N/A	Ramp inside XWalk1?	N/A		Storm Grate/Utility Type			
N/A	Any Obstructions?	N/A			N/A		
	Obstruction Type		Yes	Surface Condition? (G/P)	Good		
		N/A	N/A	Curb Slope (%)	9.3

Possible Solutions:

Remove & Replace Entire Ramp.

PROW/ADA:

R304.5.1, R304.2.2
