Access Compliance Report

Public Rights-of-Way

(Curb Ramps)

Intersection ID: 2941	Main Street: GOLDENFIELD_DR	Cross Street: SUMMER_CREEK_LN	Location: SE
ADA ID: B1FDDE1C6102	Ramp Type: BlendTrans1	Initial Pass/Fail: Fail	Overall Compliance: No
		Severity Score: 10

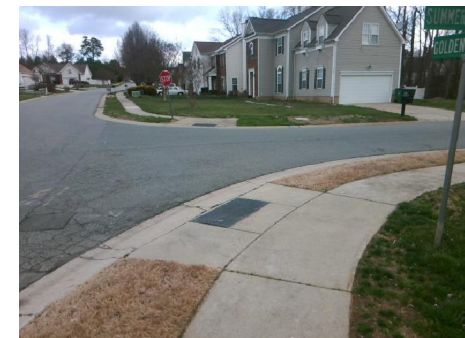
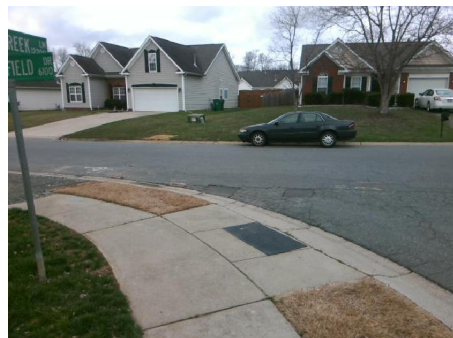
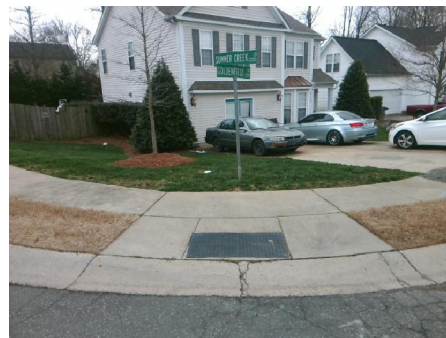
Not Found, R304.5.1, R304.5.3

Compliance	Description	Data	Compliance	Description	Data
N/A	Ramp Length (in)	47.0	Yes	BlendTrans Slope (%)	2.8
No	Ramp Width (in)	44.0	No	BlendTrans XSlope (%)	2.2
N/A	Flare Type LT	N/A	N/A	Flare Type RT	N/A
N/A	Flare Slope LT (%)	N/A	N/A	Flare Slope RT (%)	N/A
N/A	Flare Traversable LT?	N/A	N/A	Flare Traversable RT?	N/A
N/A	Landing Length (in)	N/A	N/A	DWS Provided?	N/A
N/A	Landing Width (in)	N/A	N/A	DWS Contrast?	N/A
N/A	Landing Slope (%)	N/A	N/A	DWS Length (in)	N/A
N/A	Landing X Slope (%)	N/A	N/A	DWS Full Width?	N/A
N/A	Landing Curb? (Y/N)	N/A	N/A	DWS Offset (in)	N/A
N/A	Shared Landing?	N/A			
N/A	Gutter Ponding?	N/A	N/A	Gutter Slope (%)	N/A
N/A	Gutter Lip Ht (in)	N/A	N/A	Gutter X Slope (%)	N/A
N/A	Painted X Walk1?	No	N/A	Painted X Walk2?	N/A
	X Walk 1 Direction	To NE		X Walk 2 Direction	N/A
	X Walk 1 Width (in)	N/A		X Walk 2 Width (in)	N/A
	X Walk 1 Slope (%)	3.6		X Walk 2 Slope (%)	N/A
	X Walk 1 X Slope (%)	0.0		X Walk 2 X Slope (%)	N/A

N/A	Ramp inside XWalk1?	N/A	N/A	Ramp inside XWalk2?	N/A
	Road Slope (%)	0.0		Clear Space?	N/A
	Road X Slope (%)	3.6	N/A	Clear Space to XWalk (in)	N/A
N/A	Any Obstructions?	N/A	N/A	Storm Grate/Utility Hazard?	N/A
	Obstruction Type			Storm Grate/Utility Type	
		N/A			N/A
			Yes	Surface Condition? (G/P)	Good
			No	Curb Slope (%)	17.8

Remove & Replace Curb Ramp With Two New Directional Ramps or Equivalent.
