Access Compliance Report

Public Rights-of-Way

(Curb Ramps)

Intersection ID: 16346	Main Street: BEAL_ST	Cross Street: MCALWAY_RD	Location: S
ADA ID: B1FF3AF120CF	Ramp Type: Perp	Initial Pass/Fail: Fail	Overall Compliance: No
Severity Score: 13.75			
Codes/Mitigation Info/Possible Solution		Field Measurements/Component Compliance

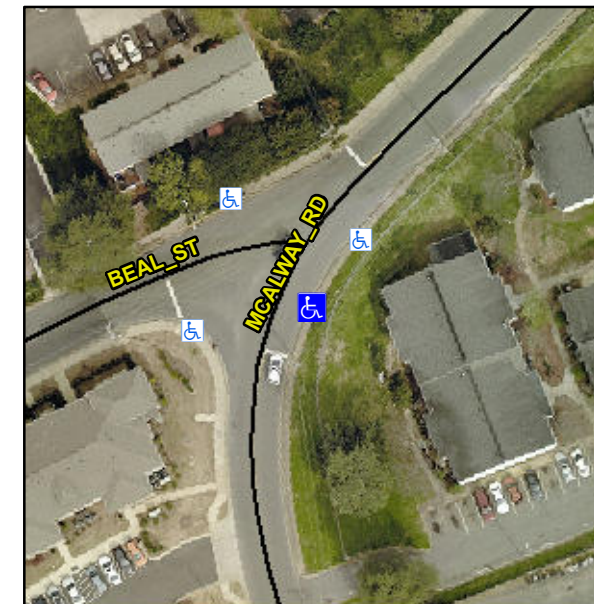
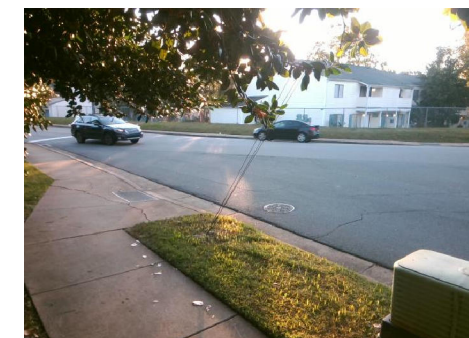
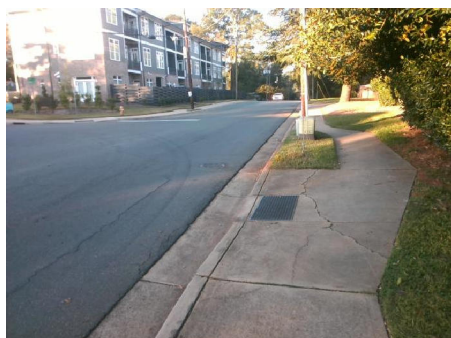
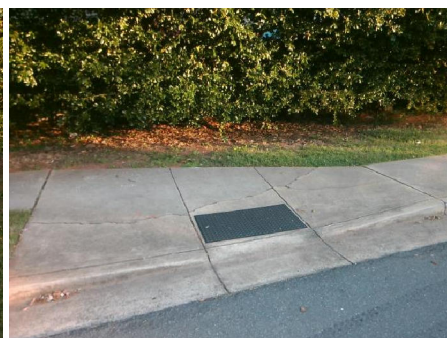
Not Found, R304.2.2, R304.5.3

Compliance	Description	Data	Compliance	Description	Data
N/A	Ramp Length (in)	82.0	No	Ramp Slope (%)	8.6
Yes	Ramp Width (in)	52.0	No	Ramp XSlope (%)	3.6
N/A	Flare Type LT	N/A	N/A	Flare Type RT	N/A
N/A	Flare Slope LT (%)	N/A	N/A	Flare Slope RT (%)	N/A
N/A	Flare Traversable LT?	N/A	N/A	Flare Traversable RT?	N/A
N/A	Landing Length (in)	N/A	N/A	DWS Provided?	N/A
N/A	Landing Width (in)	N/A	N/A	DWS Contrast?	N/A
N/A	Landing Slope (%)	N/A	N/A	DWS Length (in)	N/A
N/A	Landing X Slope (%)	N/A	N/A	DWS Full Width?	N/A
N/A	Landing Curb? (Y/N)	N/A	N/A	DWS Offset (in)	N/A
N/A	Shared Landing?	N/A			
N/A	Gutter Ponding?	N/A	N/A	Gutter Slope (%)	N/A
N/A	Gutter Lip Ht (in)	N/A	N/A	Gutter X Slope (%)	N/A
N/A	Painted X Walk1?	No	N/A	Painted X Walk2?	N/A
	X Walk 1 Direction	To W		X Walk 2 Direction	N/A
N/A	X Walk 1 Width (in)	N/A	N/A	X Walk 2 Width (in)	N/A
	X Walk 1 Slope (%)	2.6		X Walk 2 Slope (%)	N/A
	X Walk 1 X Slope (%)	2.8		X Walk 2 X Slope (%)	N/A

N/A	Ramp inside XWalk1?	N/A	N/A	Ramp inside XWalk2?	N/A
	Road Slope (%)	N/A	N/A	Clear Space?	N/A
	Road X Slope (%)	N/A	N/A	Clear Space to XWalk (in)	N/A
N/A	Any Obstructions?	N/A	N/A	Storm Grate/Utility Hazard?	N/A
	Obstruction Type			Storm Grate/Utility Type	
		N/A			N/A
			Yes	Surface Condition? (G/P)	Good

Remove & Replace Entire Ramp.
