Access Compliance Report

Public Rights-of-Way

(Curb Ramps)

Intersection ID: 10096	Main Street: SELDON_DR	Cross Street: W_TRADE_ST	Location:	N
ADA ID: B2011F6C85BF	Ramp Type: Perp	Initial Pass/Fail: Fail	Overall Compliance: No	Severity Score: 22.5
Codes/Mitigation Info/Possible Solution		Field Measurements/Component Compliance

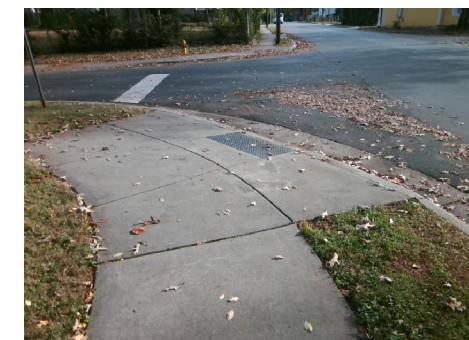
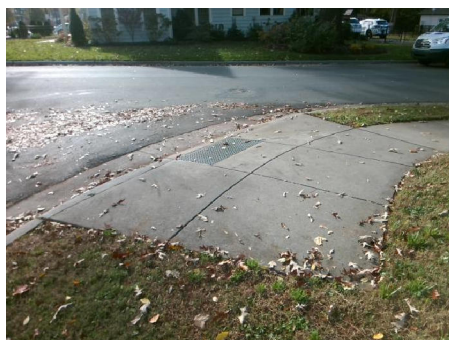
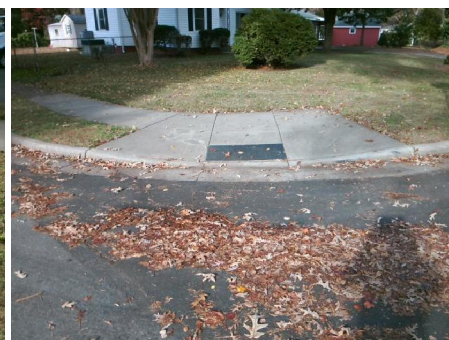
Not Found, R304.5.1, R304.2.2, R304.5.3

Compliance	Description	Data	Compliance	Description	Data
N/A	Ramp Length (in)	49.0	No	Ramp Slope (%)	9.5
No	Ramp Width (in)	47.5	No	Ramp XSlope (%)	3.3
N/A	Flare Type LT	N/A	N/A	Flare Type RT	N/A
N/A	Flare Slope LT (%)	N/A	N/A	Flare Slope RT (%)	N/A
N/A	Flare Traversable LT?	N/A	N/A	Flare Traversable RT?	N/A
N/A	Landing Length (in)	N/A	N/A	DWS Provided?	N/A
N/A	Landing Width (in)	N/A	N/A	DWS Contrast?	N/A
N/A	Landing Slope (%)	N/A	N/A	DWS Length (in)	N/A
N/A	Landing X Slope (%)	N/A	N/A	DWS Full Width?	N/A
N/A	Landing Curb? (Y/N)	N/A	N/A	DWS Offset (in)	N/A
N/A	Shared Landing?	N/A			
N/A	Gutter Ponding?	N/A	N/A	Gutter Slope (%)	N/A
N/A	Gutter Lip Ht (in)	N/A	N/A	Gutter X Slope (%)	N/A
N/A	Painted X Walk1?	No	N/A	Painted X Walk2?	N/A
	X Walk 1 Direction	To SE		X Walk 2 Direction	N/A
N/A	X Walk 1 Width (in)	N/A	N/A	X Walk 2 Width (in)	N/A
	X Walk 1 Slope (%)	2.6		X Walk 2 Slope (%)	N/A
	X Walk 1 X Slope (%)	2.4		X Walk 2 X Slope (%)	N/A

N/A	Ramp inside XWalk1?	N/A	N/A	Ramp inside XWalk2?	N/A
	Road Slope (%)	N/A	N/A	Clear Space?	N/A
	Road X Slope (%)	N/A	N/A	Clear Space to XWalk (in)	N/A
N/A	Any Obstructions?	N/A	N/A	Storm Grate/Utility Hazard?	N/A
	Obstruction Type			Storm Grate/Utility Type	
		N/A			N/A
			Yes	Surface Condition? (G/P)	Good

Possible Solutions:

Remove & Replace Entire Ramp.
