Access Compliance Report

Public Rights-of-Way

(Curb Ramps)

Intersection ID: 17448	Main Street: AMBER_CRESTE_LN	Cross Street: CITY_VIEW_DR	Location: NW
ADA ID: B2015A2B0BBC	Ramp Type: PerpDiag	Initial Pass/Fail: Fail	Overall Compliance: No
		Severity Score: 12.5

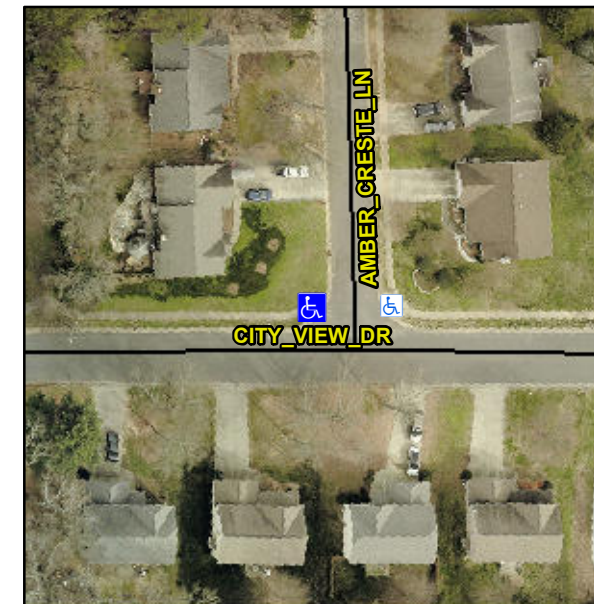
Compliance	Description	Data	Compliance	Description	Data
N/A	Ramp Length (in)	51.0	No	Ramp Slope (%)	8.6
Yes	Ramp Width (in)	48.0	Yes	Ramp XSlope (%)	0.7
N/A	Flare Type LT	N/A	N/A	Flare Type RT	N/A
N/A	Flare Slope LT (%)	N/A	N/A	Flare Slope RT (%)	N/A
N/A	Flare Traversable LT?	N/A	N/A	Flare Traversable RT?	N/A
N/A	Landing Length (in)	N/A	N/A	DWS Provided?	N/A
N/A	Landing Width (in)	N/A	N/A	DWS Contrast?	N/A
N/A	Landing Slope (%)	N/A	N/A	DWS Length (in)	N/A
N/A	Landing X Slope (%)	N/A	N/A	DWS Full Width?	N/A
N/A	Landing Curb? (Y/N)	N/A	N/A	DWS Offset (in)	N/A
N/A	Shared Landing?	N/A			
N/A	Gutter Ponding?	N/A	N/A	Gutter Slope (%)	N/A
N/A	Gutter Lip Ht (in)	N/A	N/A	Gutter X Slope (%)	N/A
N/A	Painted X Walk1?	No	N/A	Painted X Walk2?	No
	X Walk 1 Direction	To S		X Walk 2 Direction	To SE
N/A	X Walk 1 Width (in)	N/A	N/A	X Walk 2 Width (in)	N/A
	X Walk 1 Slope (%)	0.8		X Walk 2 Slope (%)	1.3
	X Walk 1 X Slope (%)	0.0		X Walk 2 X Slope (%)	2.0

N/A	Ramp inside XWalk1?	N/A	N/A	Ramp inside XWalk2?	N/A
	Road Slope (%)	0.6	N/A	Clear Space?	N/A
	Road X Slope (%)	1.6	N/A	Clear Space to XWalk (in)	N/A
N/A	Any Obstructions?	N/A	N/A	Storm Grate/Utility Hazard?	N/A
	Obstruction Type			Storm Grate/Utility Type	
		N/A			N/A
		Yes		Surface Condition? (G/P)	Good

Possible Solutions:

Remove & Replace Curb Ramp With Two New Directional Ramps or Equivalent.

R304.2.2
