Access Compliance Report

Public Rights-of-Way

(Curb Ramps)

Intersection ID: 11754	Main Street: MECKLENBURG_AV	Cross Street: THURMOND_PL	Location: SE
ADA ID: B205C82E82CB	Ramp Type: Perp	Initial Pass/Fail: Fail	Overall Compliance: No
		Severity Score: 12.5

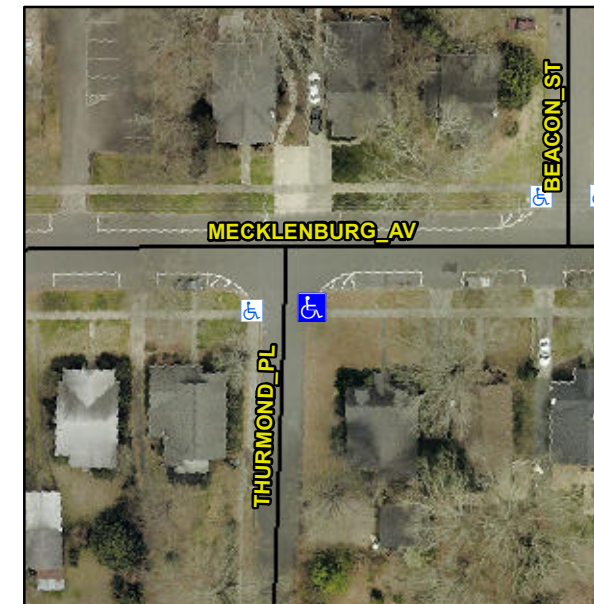
Not Found, R304.2.2

Compliance	Description	Data	Compliance	Description	Data
N/A	Ramp Length (in)	111.5	No	Ramp Slope (%)	9.3
Yes	Ramp Width (in)	57.0	Yes	Ramp XSlope (%)	1.0
N/A	Flare Type LT	N/A	N/A	Flare Type RT	N/A
N/A	Flare Slope LT (%)	N/A	N/A	Flare Slope RT (%)	N/A
N/A	Flare Traversable LT?	N/A	N/A	Flare Traversable RT?	N/A
N/A	Landing Length (in)	N/A	N/A	DWS Provided?	N/A
N/A	Landing Width (in)	N/A	N/A	DWS Contrast?	N/A
N/A	Landing Slope (%)	N/A	N/A	DWS Length (in)	N/A
N/A	Landing X Slope (%)	N/A	N/A	DWS Full Width?	N/A
N/A	Landing Curb? (Y/N)	N/A	N/A	DWS Offset (in)	N/A
N/A	Shared Landing?	N/A			
N/A	Gutter Ponding?	N/A	N/A	Gutter Slope (%)	N/A
N/A	Gutter Lip Ht (in)	N/A	N/A	Gutter X Slope (%)	N/A
N/A	Painted X Walk1?	No	N/A	Painted X Walk2?	N/A
	X Walk 1 Direction	To W		X Walk 2 Direction	N/A
N/A	X Walk 1 Width (in)	N/A	N/A	X Walk 2 Width (in)	N/A
	X Walk 1 Slope (%)	1.5		X Walk 2 Slope (%)	N/A
	X Walk 1 X Slope (%)	6.1		X Walk 2 X Slope (%)	N/A

N/A	Ramp inside XWalk1?	N/A	N/A	Ramp inside XWalk2?	N/A
	Road Slope (%)	N/A	N/A	Clear Space?	N/A
	Road X Slope (%)	N/A	N/A	Clear Space to XWalk (in)	N/A
N/A	Any Obstructions?	N/A	N/A	Storm Grate/Utility Hazard?	N/A
	Obstruction Type			Storm Grate/Utility Type	
		N/A			N/A
			Yes	Surface Condition? (G/P)	Good

Possible Solutions:

Remove & Replace Entire Ramp.
