# Access Compliance Report

## Public Rights-of-Way

| Intersection ID: 2864 | Main Street: ROCK_STREAM_DR | Cross Street: WAVERLY_LYNN_LN | Location: | E |
| ADA ID: B20BAB21D483 | Ramp Type: BlendTrans1 | Initial Pass/Fail: Fail | Overall Compliance: No | Severity Score: 8.75 |

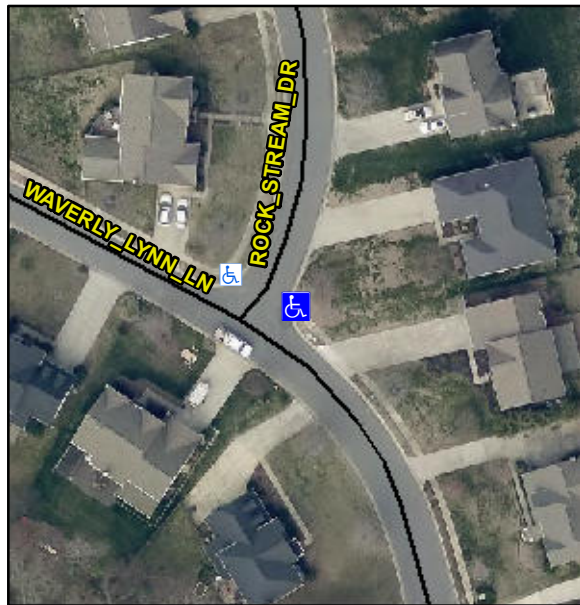
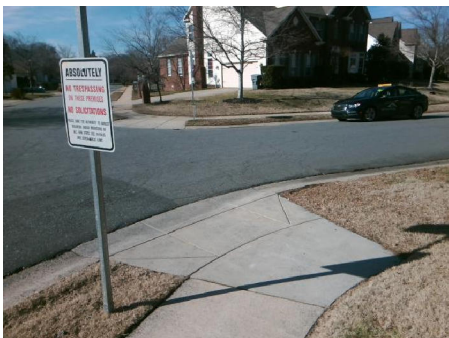
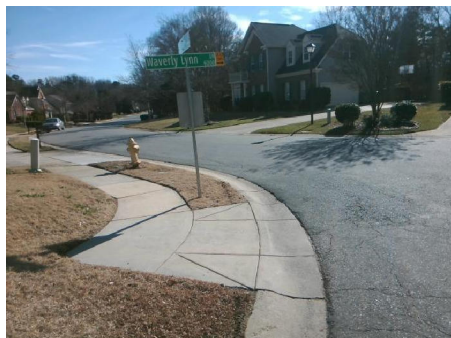
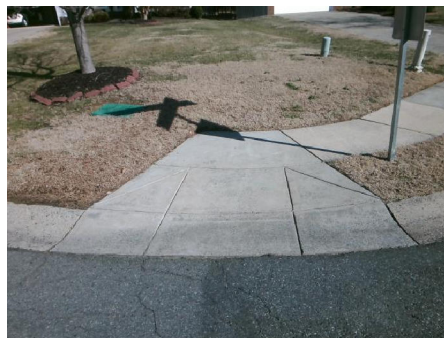
**Not Found, R304.5.1**

| Compliance | Description | Data | Compliance | Description | Data |
|---|---|---|---|---|---|
| No | Ramp Width (in) | 46.0 | Yes | BlendTrans XSlope (%) | 0.3 |
| | | | No | Curb Slope (%) | 8.5 |

**Remove & Replace Curb Ramp With Two New Directional Ramps or Equivalent.**
