Access Compliance Report Public Rights-of-Way (Curb Ramps)

Intersection ID: 27610 Main Street: JOHNSTON_RD Cross Street: JOHN_J_DELANEY_DR Location: SE

ADA ID: B20E6A9213E1 Ramp Type: Perp Initial Pass/Fail: Fail Overall Compliance: No Severity Score: 12.5

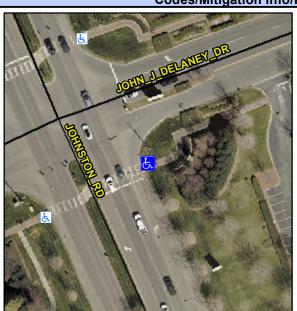
Field Measurements/Component Compliance							
Comp	liance Description	Data	Comp	liance Description	Data		
N/A	Ramp Length (in)	49.0	No	Ramp Slope (%)	9.7		
Yes	Ramp Width (in)	60.0	Yes	Ramp XSlope (%)	0.5		
N/A	Flare Type LT	N/A	N/A	Flare Type RT	N/A		
N/A	Flare Slope LT (%)	N/A	N/A	Flare Slope RT (%)	N/A		
N/A	Flare Traversable LT?	N/A	N/A	Flare Traversable RT?	N/A		
N/A	Landing Length (in)	N/A	N/A	DWS Provided?	N/A		
N/A	Landing Width (in)	N/A	N/A	DWS Contrast?	N/A		
N/A	Landing Slope (%)	N/A	N/A	DWS Length (in)	N/A		
N/A	Landing X Slope (%)	N/A	N/A	DWS Full Width?	N/A		
N/A	Landing Curb? (Y/N)	N/A	N/A	DWS Offset (in)	N/A		
N/A	Shared Landing?	N/A					
N/A	Gutter Ponding?	N/A	N/A	Gutter Slope (%)	N/A		
N/A	Gutter Lip Ht (in)	N/A	N/A	Gutter X Slope (%)	N/A		
N/A	Painted X Walk1?	Yes	N/A	Painted X Walk2?	N/A		
	X Walk 1 Direction	To W		X Walk 2 Direction	N/A		
N/A	X Walk 1 Width (in)	114.0	N/A	X Walk 2 Width (in)	N/A

X Walk 1 Slope (%)	6.3		X Walk 2 Slope (%)	N/A		
	X Walk 1 X Slope (%)	1.5		X Walk 2 X Slope (%)	N/A		
N/A	Ramp inside XWalk1?	Yes	N/A	Ramp inside XWalk2?	N/A		
	Road Slope (%)	N/A	N/A	Clear Space?	N/A		
	Road X Slope (%)	N/A	N/A	Clear Space to XWalk (in)	N/A		
N/A	Any Obstructions?	N/A	N/A	Storm Grate/Utility Hazard?	N/A		
	Obstruction Type			Storm Grate/Utility Type			
		N/A			N/A		
			Yes	Surface Condition? (G/P)	Good

1 COCIDIO COIGNOII	
Possible Solutions:	Com
Remove & Replace Entire Ramp.	N/A
	Yes
	N/A
	N/A
	N/A
	N/A
Surveyor Notes:	N/A
N/A	N/A
	N/A
	N/A
	N/A
PROW/ADA:	N/A
Not Found, R304.2.2	N/A
	N/A
	N/A
	N/A
