# Access Compliance Report

## Public Rights-of-Way

| Intersection ID: 19764 | Main Street: KREFELD_DR | Cross Street: KREFELD_GLEN_DR | Location: | N |
| ADA ID: B2118FF79E25 | Ramp Type: BlendTrans2 | Initial Pass/Fail: Fail | Overall Compliance: No | Severity Score: 30 |

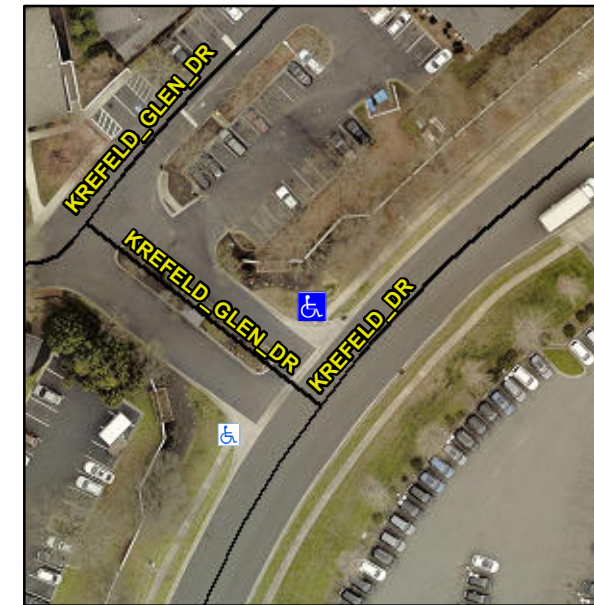
**Not Found, R304.5.1, R304.5.3**

| Compliance | Description | Data | Compliance | Description | Data |
|---|---|---|---|---|---|
| N/A | Ramp Length (in) | 34.0 | Yes | BlendTrans Slope (%) | 0.9 |
| No | Ramp Width (in) | 32.0 | No | BlendTrans XSlope (%) | 5.2 |

**Remove & Replace Curb Ramp With Two New Directional Ramps or Equivalent.**

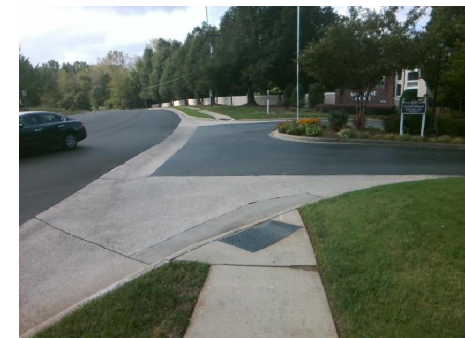
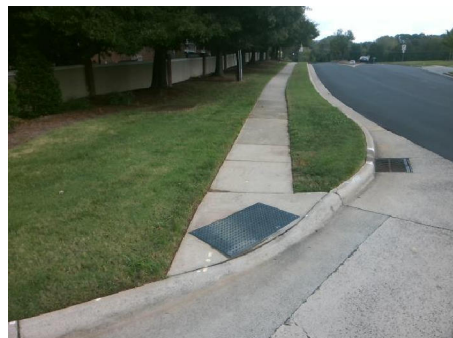
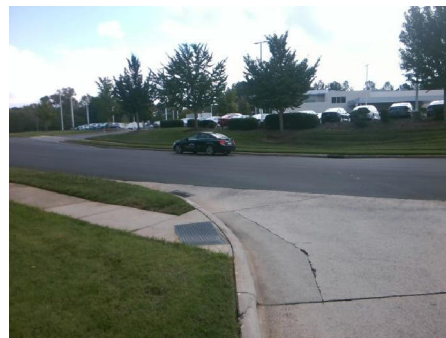
Street 1 Name KREFELD GLEN DR  
 Stop Condition-Street 1 StopSign  
 Street 2 Name KREFELD DR  
 Stop Condition-Street 2 None
