Access Compliance Report

Public Rights-of-Way

(Curb Ramps)

Intersection ID: 48984	Main Street: ASHTON_GATE_DR	Cross Street: KINGSDOWN_AV	Location: SE
ADA ID: B222252D45E4	Ramp Type: BlendTrans1	Initial Pass/Fail: Fail	Overall Compliance: No
Severity Score: 12.5			
Codes/Mitigation Info/Possible Solution		Field Measurements/Component Compliance

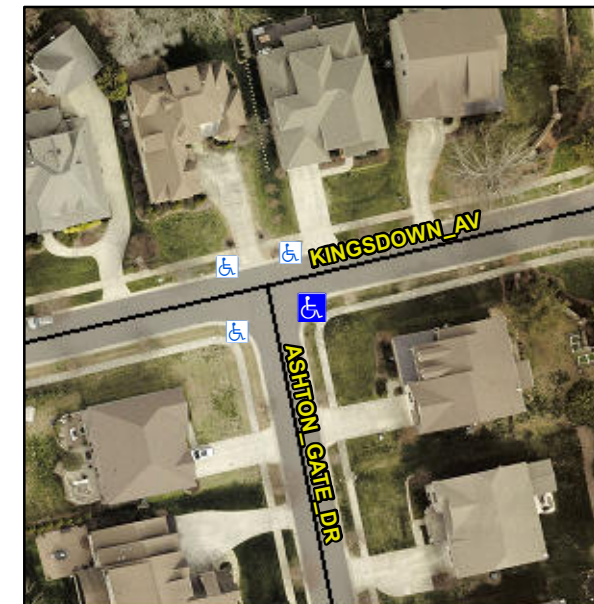
Not Found, R304.5.3

Compliance	Description	Data	Compliance	Description	Data
N/A	Ramp Length (in)	70.0	Yes	BlendTrans Slope (%)	2.8
Yes	Ramp Width (in)	49.5	No	BlendTrans XSlope (%)	5.4
N/A	Flare Type LT	N/A	N/A	Flare Type RT	N/A
N/A	Flare Slope LT (%)	N/A	N/A	Flare Slope RT (%)	N/A
N/A	Flare Traversable LT?	N/A	N/A	Flare Traversable RT?	N/A
N/A	Landing Length (in)	N/A	N/A	DWS Provided?	N/A
N/A	Landing Width (in)	N/A	N/A	DWS Contrast?	N/A
N/A	Landing Slope (%)	N/A	N/A	DWS Length (in)	N/A
N/A	Landing X Slope (%)	N/A	N/A	DWS Full Width?	N/A
N/A	Landing Curb? (Y/N)	N/A	N/A	DWS Offset (in)	N/A
N/A	Shared Landing?	N/A			
N/A	Gutter Ponding?	N/A	N/A	Gutter Slope (%)	N/A
N/A	Gutter Lip Ht (in)	N/A	N/A	Gutter X Slope (%)	N/A
N/A	Painted X Walk1?	No	N/A	Painted X Walk2?	No
	X Walk 1 Direction	To NW		X Walk 2 Direction	To SW
	X Walk 1 Width (in)	N/A		X Walk 2 Width (in)	N/A
	X Walk 1 Slope (%)	2.5		X Walk 2 Slope (%)	0.2
	X Walk 1 X Slope (%)	0.8		X Walk 2 X Slope (%)	4.4

N/A	Ramp inside XWalk1?	N/A	N/A	Ramp inside XWalk2?	N/A
	Road Slope (%)	4.6		Clear Space?	N/A
	Road X Slope (%)	2.3	N/A	Clear Space to XWalk (in)	N/A
N/A	Any Obstructions?	N/A	N/A	Storm Grate/Utility Hazard?	N/A
	Obstruction Type			Storm Grate/Utility Type	
		N/A			N/A
			Yes	Surface Condition? (G/P)	Good
			No	Curb Slope (%)	7.4

Remove & Replace Curb Ramp With Two New Directional Ramps or Equivalent.
