Access Compliance Report

Public Rights-of-Way

(Curb Ramps)

Intersection ID: 50616	Main Street: PADDLE_OAK_RD	Cross Street: FAWN_LILY	Location: NE
ADA ID: B223D2A4855C	Ramp Type: Perp	Initial Pass/Fail: Fail	Overall Compliance: No
Severity Score: 8.75			
Codes/Mitigation Info/Possible Solution		Field Measurements/Component Compliance

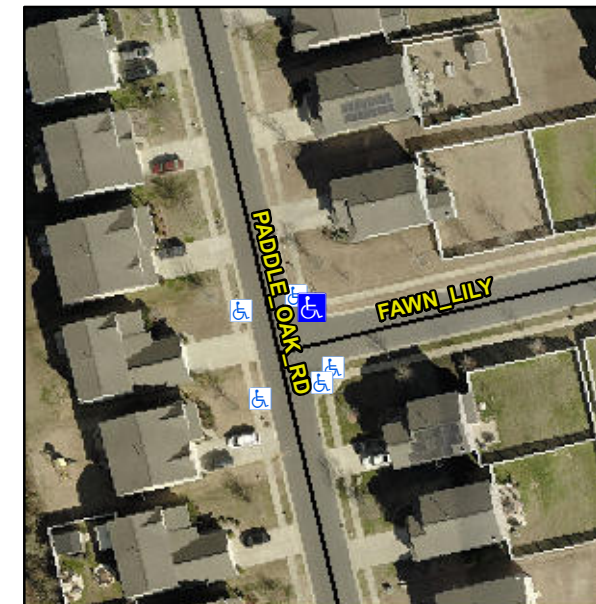
Compliance	Description	Data	Compliance	Description	Data
N/A	Ramp Length (in)	48.0	Yes	Ramp Slope (%)	7.3
No	Ramp Width (in)	47.5	Yes	Ramp XSlope (%)	0.7
N/A	Flare Type LT	N/A	N/A	Flare Type RT	N/A
N/A	Flare Slope LT (%)	N/A	N/A	Flare Slope RT (%)	N/A
N/A	Flare Traversable LT?	N/A	N/A	Flare Traversable RT?	N/A
N/A	Landing Length (in)	N/A	N/A	DWS Provided?	N/A
N/A	Landing Width (in)	N/A	N/A	DWS Contrast?	N/A
N/A	Landing Slope (%)	N/A	N/A	DWS Length (in)	N/A
N/A	Landing X Slope (%)	N/A	N/A	DWS Full Width?	N/A
N/A	Landing Curb? (Y/N)	N/A	N/A	DWS Offset (in)	N/A
N/A	Shared Landing?	N/A			
N/A	Gutter Ponding?	N/A	N/A	Gutter Slope (%)	N/A
N/A	Gutter Lip Ht (in)	N/A	N/A	Gutter X Slope (%)	N/A
N/A	Painted X Walk1?	No	N/A	Painted X Walk2?	N/A
	X Walk 1 Direction	To S		X Walk 2 Direction	N/A
N/A	X Walk 1 Width (in)	N/A	N/A	X Walk 2 Width (in)	N/A
	X Walk 1 Slope (%)	4.2		X Walk 2 Slope (%)	N/A
	X Walk 1 X Slope (%)	2.0		X Walk 2 X Slope (%)	N/A

N/A	Ramp inside XWalk1?	N/A	N/A	Ramp inside XWalk2?	N/A
	Road Slope (%)	N/A	N/A	Clear Space?	N/A
	Road X Slope (%)	N/A	N/A	Clear Space to XWalk (in)	N/A
N/A	Any Obstructions?	N/A	N/A	Storm Grate/Utility Hazard?	N/A
	Obstruction Type			Storm Grate/Utility Type	
		N/A			N/A
			Yes	Surface Condition? (G/P)	Good

Possible Solutions:

Remove & Replace Entire Ramp.

R304.5.1
